GROUP	MODEL
BOD	2018-2023MY
	Rio (SC) and
	2019-2024MY
	Forte (BDm)
NUMBER	DATE
212 (Rev 1, 11/02/2023)	March 2021

TECHNICAL SERVICE BULLETIN

PARTIAL SEAT TRACK REPLACEMENT FOR INOPERATIVE FRONT SEAT

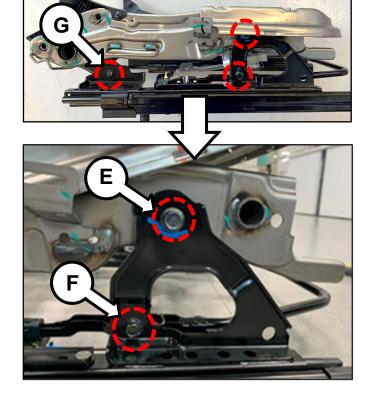
6. Remove the three (3) rail retaining bolts (Front: E, slide: F, rear: G) to separate the rail from the track mechanism.
