GROUP	MODEL
BOD	2023MY K5 (DL3a)
NUMBER	DATE
322	November 2023

## TECHNICAL SERVICE BULLETIN

### SERVICE ACTION: TRUNK LID AND C-PILLAR GARNISH INSPECTION & REPLACEMENT (SA552)

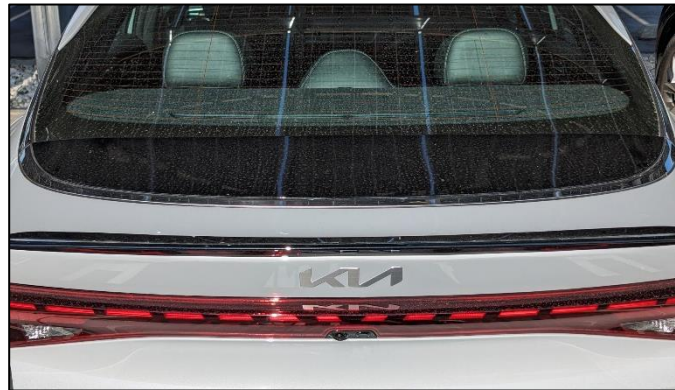
This bulletin provides information to inspect the rear trunk lid chrome garnish trim and the C-Pillar(s) chrome garnish trim on certain 2023MY K5 (DL3a) vehicles produced from May 1, 2023 through September 29, 2023, which may be loose due to an insufficient lamination layer. Follow the procedure outlined in this publication to inspect the rear trunk lid chrome trim, and both left and right side C-pillar chrome trims, and replace the affected rear trunk lid chrome trim and/or the (left and/or right side) C-Pillar(s) chrome trim on the applicable vehicle. Before conducting the procedure, verify that the vehicle is included in the list of affected VINs.

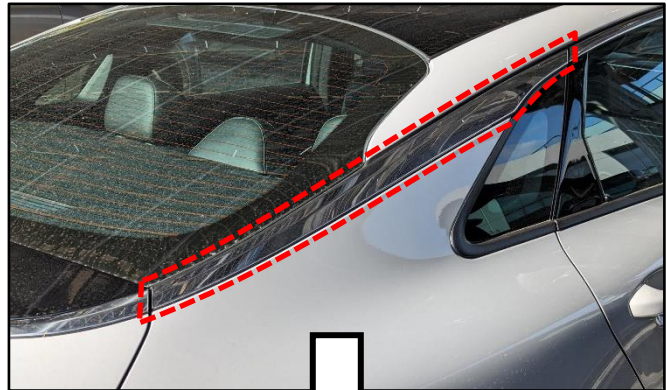
- Using a non-marring plastic trim tool, carefully pry 'light' upward pressure in between the rear C-Pillar chrome garnish rubber and the body.

- If the rear chrome C-Pillar garnish is not separated (loose) when inspected **(OK)**, then no further action is required unless the rear trunk lid garnish requires replacement.
- If the rear chrome C-Pillar garnish is separated (loose) when inspected **(NG)**, then replace the rear trunk lid garnish by referring to the 'Replacement Procedure' on page 4.
