Service Bulletin

Bulletin No.: 17-NA-394

Subject: Squeak, Clunking Type Noise Heard from Rear of Vehicle

Brand:	Model:	Model Year:		VIN:		Engine:	Transmission:
		from	to	from	to		
Chevrolet	Colorado	2015	2024			All	All
GMC	Canyon

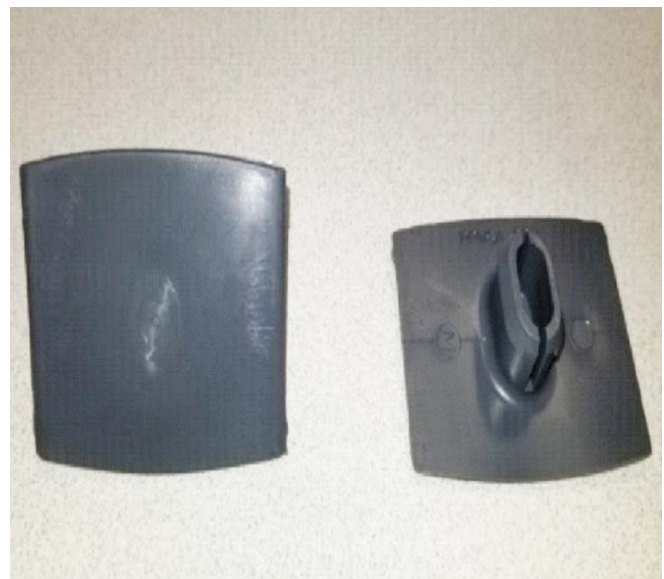
5341853

1. Raise the vehicle on a frame lift-type hoist. Refer to *Lifting and Jacking the Vehicle*, in SI.
2. Inspect the springs for damage.
 - If damage has been found, refer to *Rear Leaf Spring Replacement*, in SI.
 - If damage has NOT been found, proceed to the next step.
