Service Bulletin

Bulletin No.: 23-NA-065

Subject: OnStar Inoperative after Importing Vehicle from Canada to the United States

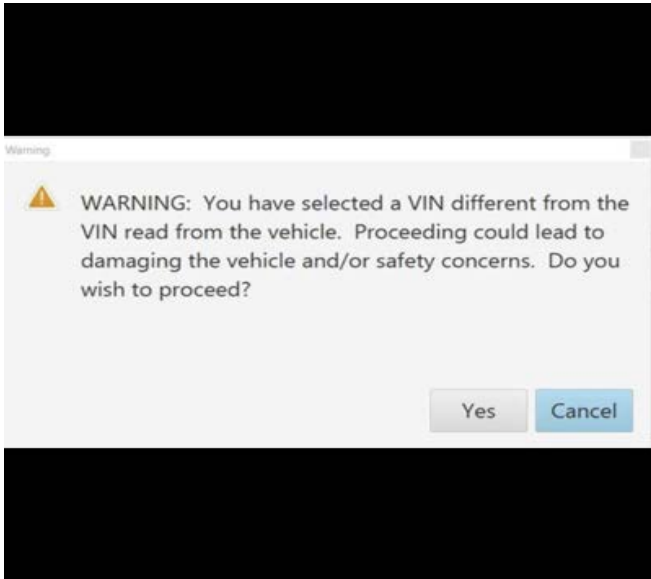
5877000

Important: If the vehicle VIN DOES NOT match, the message below will be shown.
