Service Action

Code: 34K1

Subject Transmission Control Module (TCM) Software

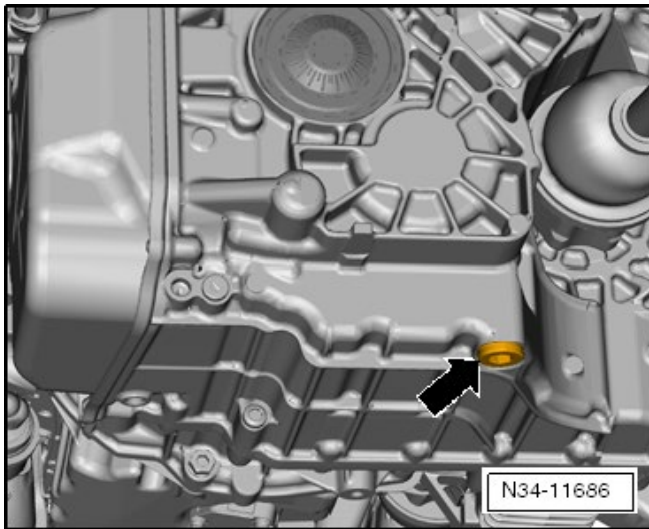
If internal or external damage caused by the auxiliary hydraulic pump bolts coming loose is found before or during the repair:

A missing bolt or damaged bolt is considered internal transmission damage.
