Service Bulletin

Bulletin No.: 23-NA-181

Subject: Excessive Brake Pedal Travel and/or Vehicle is Hard to Stop

Brand:	Model:	Model Year:		VIN Breakpoint:		Engine	Transmission:
		from	to	from	to	Engine:	Transmission.
Chevrolet	Express	2021	2023	_	_	_	_
GMC	Savana

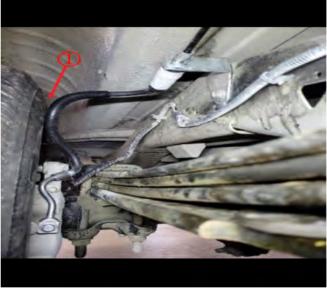
6463220

Involved Region or Country	North America		
Condition	Some customers may comment on having excessive brake pedal travel and/or the vehicle is hard to stop.

The condition may be caused by the brake hose from the frame to the rear caliper is making contact with the tire, as shown in the picture above.
