## **Service Bulletin**

## Subject: Full Size Trucks Idle Time-out Disable

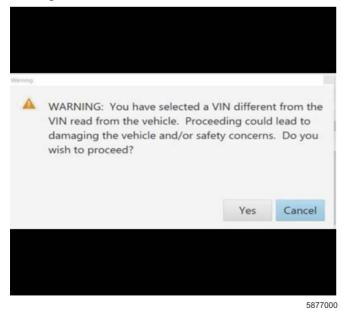
5743643

**Important:** If the vehicle VIN DOES NOT match, the message below will be shown
