Service Bulletin

Bulletin No.: 23-NA-191

Subject: Shake and/or Shudder During Steady Speed and/or Light Throttle Acceleration Between 25 and 50 MPH (40 and 80 KM/H)

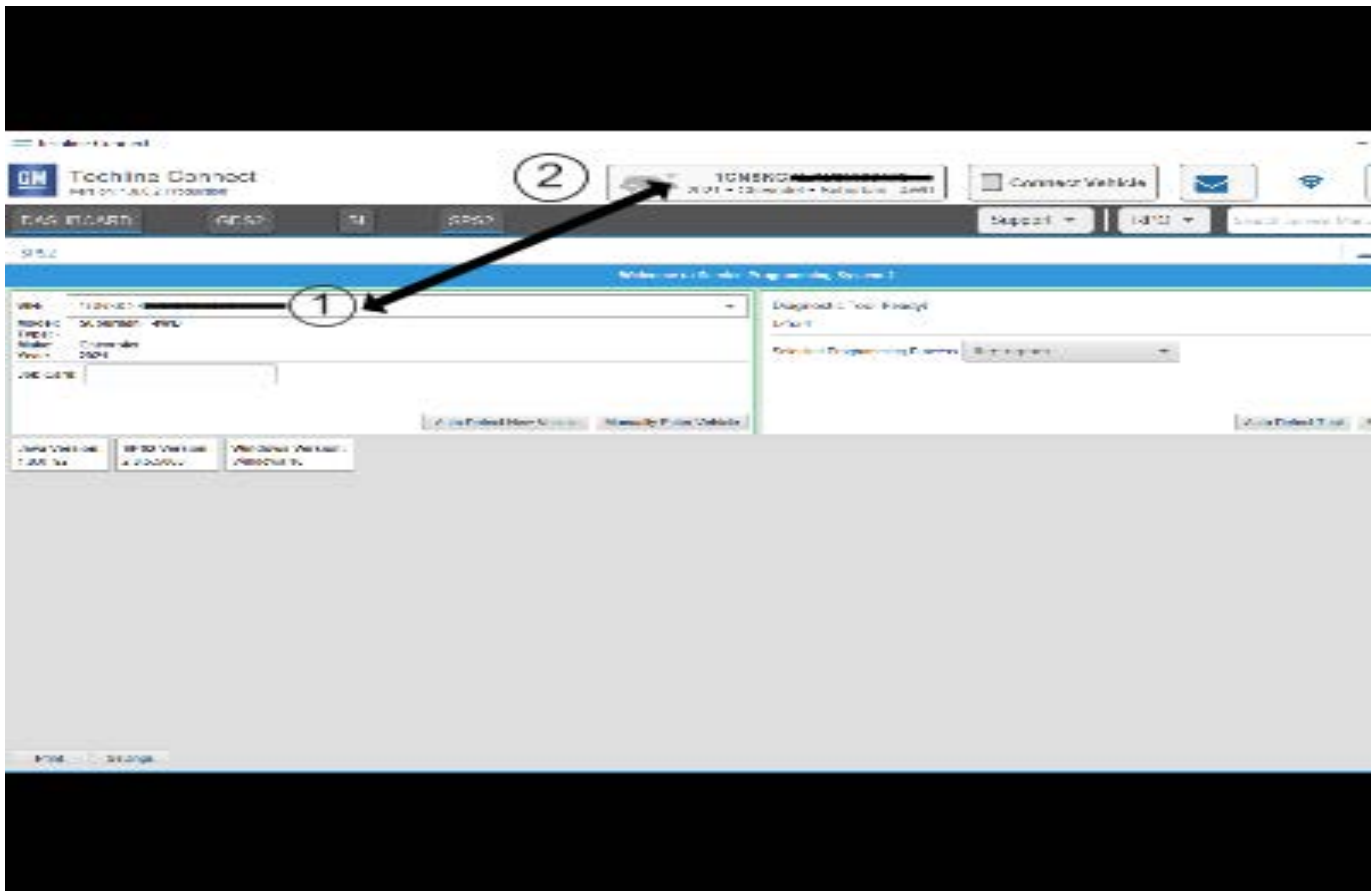
Caution: Be sure the VIN selected in the drop-down menu (1) is the same as the vehicle connected (2) before beginning programming.

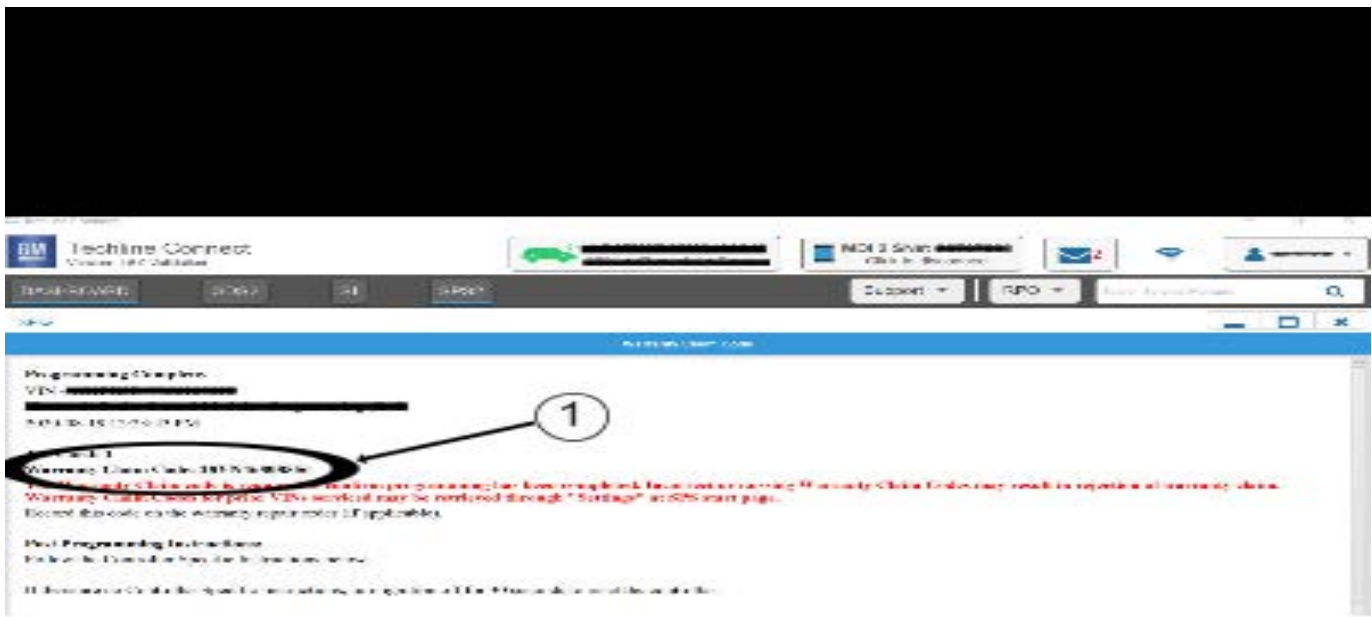
5644478

Important: If the same calibration/software warning is noted on the TLC Summary screen, select OK and follow screen instructions. After a successful programming event, the WCC is located in the Service Programming System dialogue box of the SPS Summary screen. No further action is required. Refer to the Warranty section of the bulletin.

1. Reprogram the TCM. Refer to *Transmission Control Module Programming and Setup in SI*.
