MODEL
2017MY
Multiple Models
2016-2017MY
Optima (JF)

NUMBER
072 (Rev 5, 11/09/2023)

TECHNICAL SERVICE BULLETIN

SUBJECT: SERVICE ACTION: INHIBITOR SWITCH
REPLACEMENT (SA317B/C)

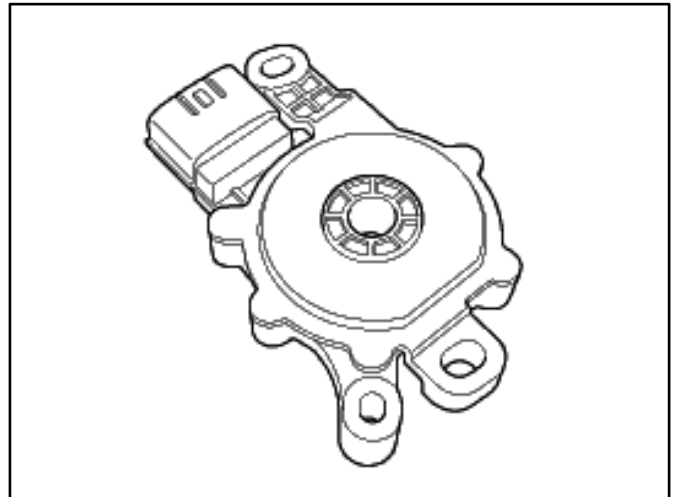
This bulletin provides the procedure to replace the inhibitor switch on some 2017MY Optima (JFa), Sorento (UMa), Optima Hybrid (HEV), Optima Plug-in Hybrid (PHEV), Sportage (QL), Forte (YD), and Sedona (YP), and some 2016-2017MY Optima (JF) vehicles, equipped with a front wheel drive 6-speed transmission, which may experience the concerns listed below. These concerns may be due to the inhibitor switch not allowing the correct gear position signal to be sent to various control units. Follow the procedure outlined in this bulletin to replace the inhibitor switch. Before conducting the procedure, verify that the vehicle is included in the list of affected VINs.

1. Replace the inhibitor switch by referring to the “Automatic Transaxle System → Automatic Transaxle Control System → Inhibitor Switch → Repair procedures” chapter of the applicable Shop Manual on KGIS.
