GROUP	MODEL
TRA	2020-2022MY Multiple Models
NUMBER	DATE
105	November 2023

TECHNICAL SERVICE BULLETIN

4WD COUPLING NOISE INSPECTION AND SNAP RING REPLACEMENT

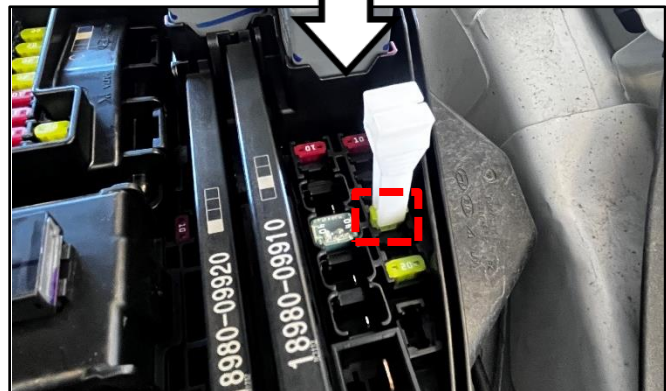
2.
 - If the noise is present and it resembles the noise in the referenced videos, remove the '20A' 4WD fuse (A) located in the engine room junction block and test drive vehicle again at speeds of 25MPH or less.
 - If a noise is present and does NOT resemble the noise in the referenced videos, **this TSB does not apply.**

3.
 - If the noise is no longer present, then proceed to the 'Replacement Procedure' on page 3.
 - If the noise is still present (other condition), refer to KGIS for troubleshooting procedures. **This TSB does not apply.**

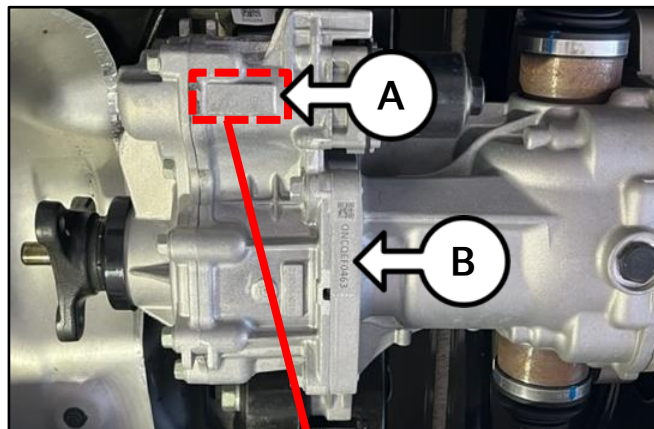
3. Identify the nine (9) digit serial number (A) located on the 4WD Coupling (B).

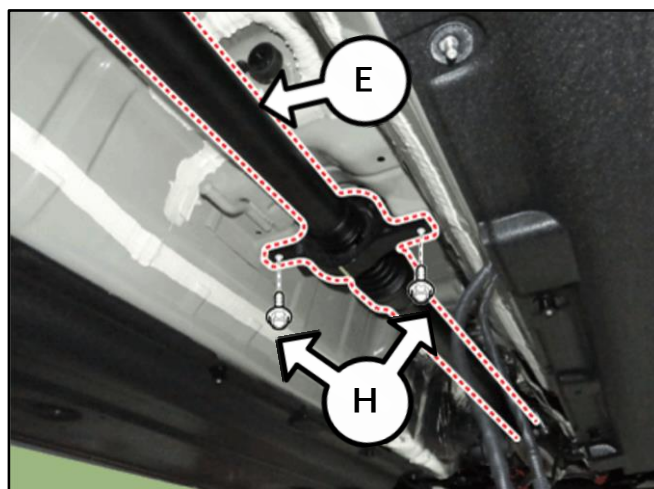
10. Loosen the two (2) center bearing bracket bolts (H) and lower propeller shaft (E).

Tightening torque for bolts (E):
 Telluride (ON)
 36.1 - 50.6 lb.ft (49.0 - 68.6 N.m)

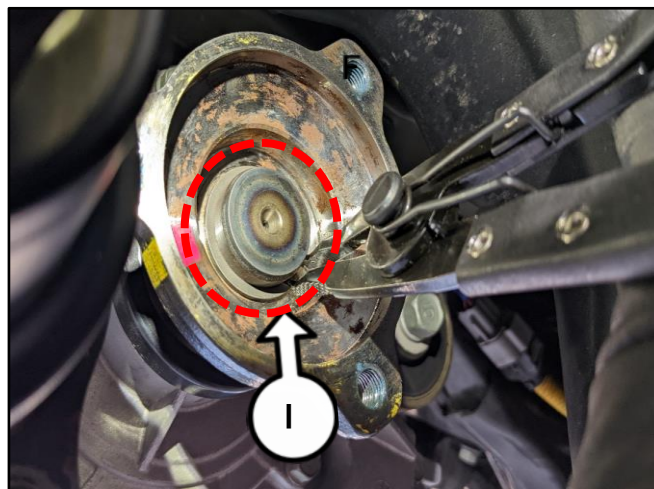
11. Using a snap ring plier, remove the snap ring (I).
