TECHNICAL SERVICE BULLETIN

Delivery/Courier Usage Only - Various Supplemental Restraint System (SRS) DTCs

23-2230

Ford
2019-2020 Transit

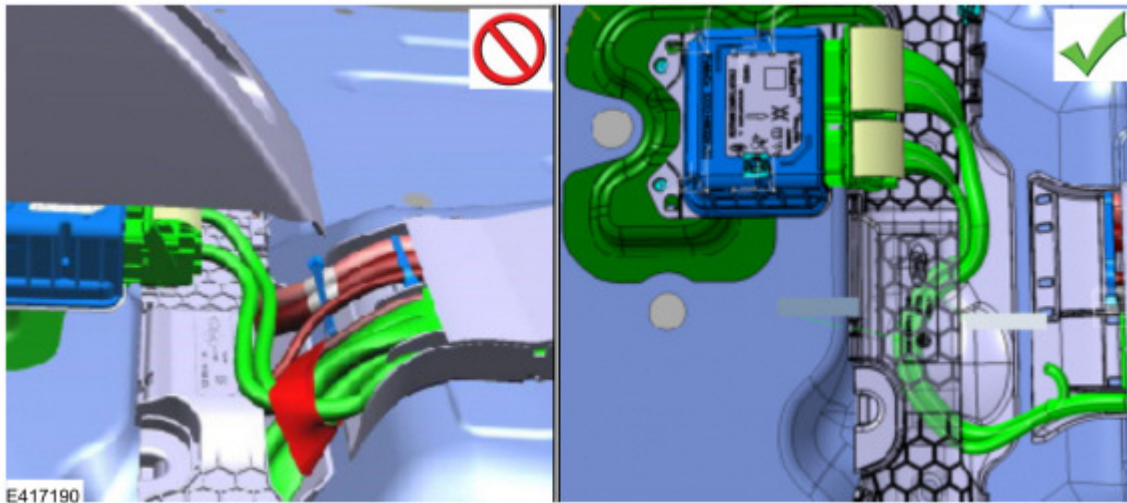
Figure 1

Issue: Some 2019-2020 Transit vehicles may exhibit various SRS diagnostic trouble codes (DTCs) when used as delivery and/or courier vehicle. This may be due to repeated rear entry of the vehicle by crossing between the front seats or stepping in the center portion of the floor near the restraints control module (RCM). To correct the condition, follow the Service Procedure to install a revised wiring harness pigtail for connection to the RCM.

1. Access the RCM and connector C310A and C310B. Refer to Workshop Manual (WSM), Section 501-20B.
2. Inspect the RCM connectors C310A and C310B for any broken hard shell, latches, pins and/or wiring. Is there any damage detected in the connectors?
 - (1). Yes - proceed to Step 3.
 - (2). No - this article does not apply. Refer to WSM for normal diagnostics.
3. Replace the RCM connectors C310A and C310B and/or associated wiring with the wiring harness pigtail.
 - (1). Lengthen the amount of wiring on the wiring harness pigtail to reroute the harness and prevent a recurrence of the issue when a user crosses or steps on the RCM location. (Figure 1) Do not shorten the wiring harness pigtail.
