SIB 41 08 22

DELIVERY STOP: TRANSMISSION HEAT SHIELD

E-Series	Model Description	Production Date
G07	X7 Sports Activity Vehicle (SAV)	September 1, 2022 – December 3, 2022

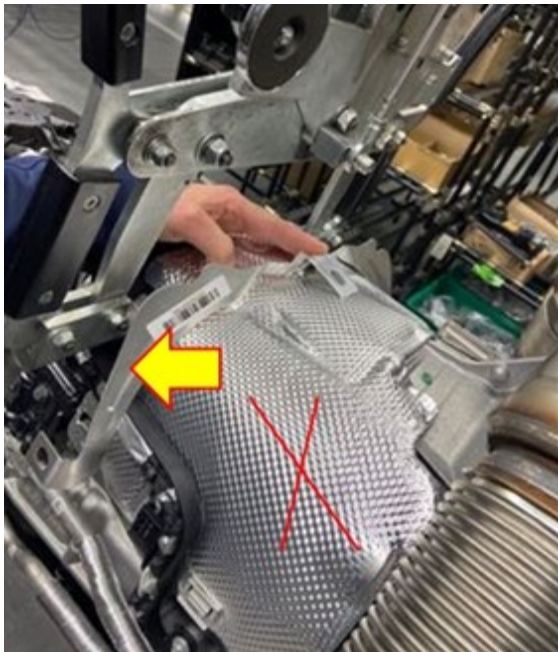
During assembly of the vehicle, a heat shield was mistakenly installed above the transmission.

Note: No heat shield should have been installed. It may contact other components in the narrow space along the bottom of the transmission tunnel.

2. Inspect transmission for the heat shield (arrow).

Note: The corrugated aluminum cover (marked with the RED X) is not the component to check for; the one at the arrow is.

- No heat shield observed: No further repairs needed. Reassembly the vehicle.
- Heat shield is present: Continue to step 3.

3. Remove the transmission following the repair instructions listed in AIR or ISTA 24 00 240 "Removing and installing automatic transmission".

- Closely inspect any electrical harnesses or fluid-carrying lines which are fastened to the underside of the transmission tunnel for damage, which may have contacted the heat shield.
- If any damage is observed, replace the component.

4. Remove and discard the heat shield.
