This Service Information Bulletin (Revision 01) replaces SI B61 03 23 dated **March 2023**.

E-Series	Model Description	Production Date
F39	X2 Sports Activity Coupe	January 1 – September 30, 2022
F48	X1 Sports Activity Vehicle

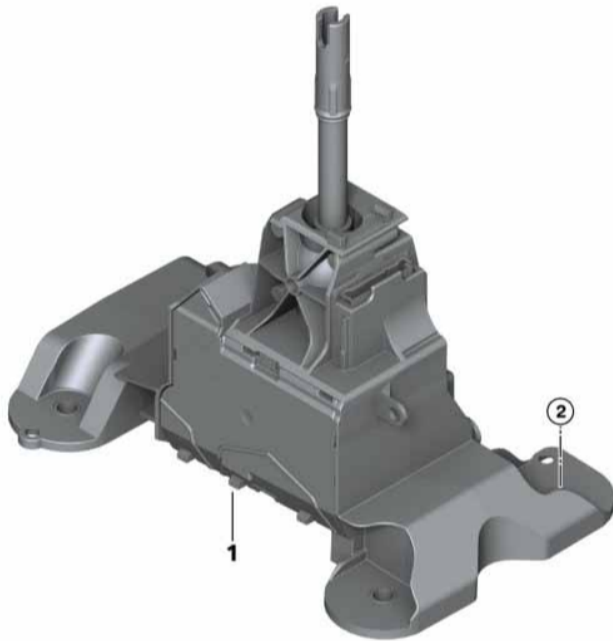
The buttons on the GWS do not work, or the function indicator lighting has failed.

Damage to the shift box (Selector Lever) ribbon cable.

Replace the shift box, then reassess the vehicle.

1. Perform a vehicle test using ISTA, read fault memory and diagnose any relevant faults.
2. Disconnect the 12 V vehicle battery.
3. Replace the Shift box (Selector Lever), refer to repair instructions **25 16 056 “Removing and installing/replacing gearshift bracket”**.
4. Reconnect the 12 V vehicle battery.
5. Utilizing ISTA, clear any fault codes induced by the defective ribbon cable.
6. Perform a sleep cycle until the hazard warning switch light goes out, this can take up to 30 minutes.
7. Wake the vehicle and verify the effectiveness of the repair by testing the functionality of the GWS.

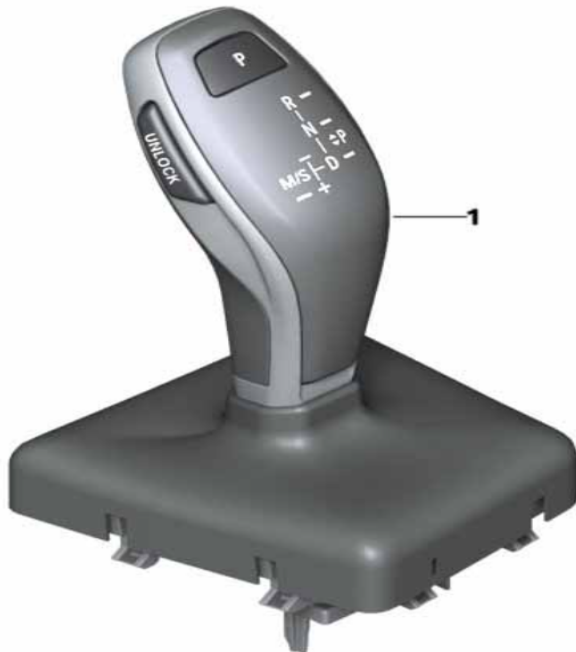
Does the GWS operate as designed? (Buttons, lighting, etc.)

- Yes:** No further action is necessary.
No: Further diagnosis with ISTA is needed.
