2023-11-02

MODEL

E-Series	Model Description	Production Date
G70	7 Series Sedan	From July 2022 to July 2023
i20	iX Sports Activity Vehicle	From November 2021 to July 2023

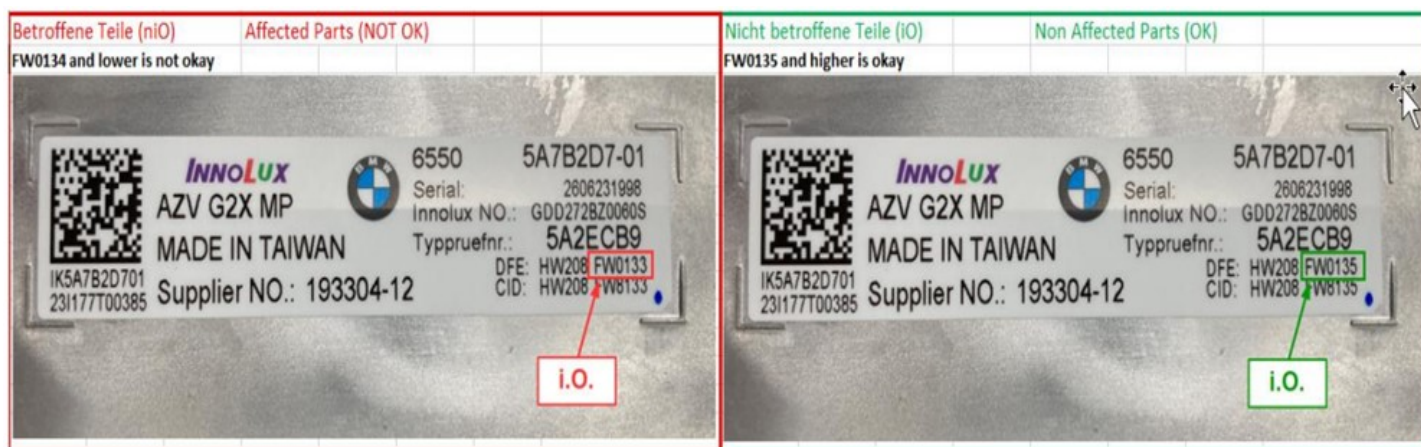
This specific issue only applies to InnoLux produced Multifunctional Displays with a firmware version of FW134 or lower.

If the vehicle's Multifunctional Display is either:

- An InnoLux product with a firmware version of FW135 or higher
- The Multifunctional Display is produced by another manufacturer

Then any distortion encountered **does not apply** to the issue described in this Service Information Bulletin. Continue with your standard diagnosis.

Remove and replace the Multifunction Display per the Premium Repair Instructions **65 50 210 - Removing and installing instrument cluster**.
