TECHNICAL SERVICE BULLETIN

Technical Service Bulletin: 205-1699

Forest River is alerting you to an issue involving certain 2023-2024 Coachmen Catalina 27THS Travel Trailer Recreational Vehicles. Please see the information below, which describes the issue and provides you with details on the steps you should take to have your vehicle repaired.

TECHNICAL SERVICE BULLETIN 205-1699 REMEDY INSTRUCTIONS

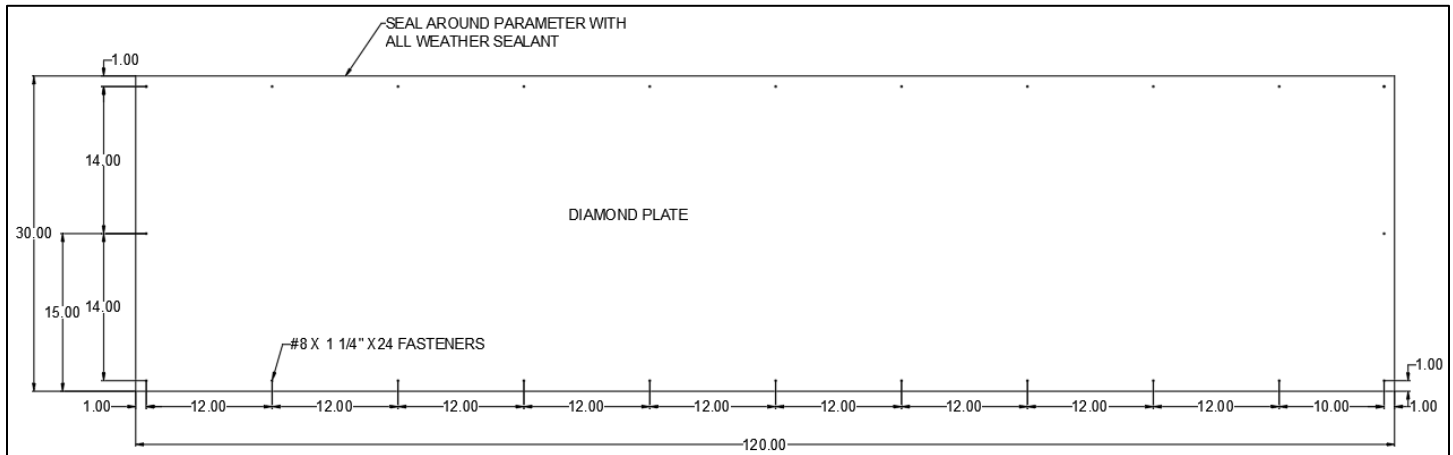
FIGURE 1:

When securing cargo using the in-floor tie-down system, an operator may cause damage to the floor of the toy hauler area.

Make(s): CATALINA Model(s): ACAT27THS Model Year(s): 2023 - 2024	Repair Code: SB-417-03-00-004438 Allotted Time: 2.00 HRS. + PARTS Inspection Code: N/A Allotted Time: N/A
	Concern: The floor needs to be reinforced in the toy hauler area.	Photo(s) Required: YES Prior Authorization Required: YES Part(s) Number: N/A Part(s) Return: N/A

STEP 1: LAY THE DIAMOND PLATE IN THE CENTER OF THE D-RINGS, FLUSH WITH THE HORSESHOE FRAME OF THE RAMP DOOR. THIS WILL LEAVE AROUND AN INCH OF SPACING BETWEEN EACH D-RING TO THE DIAMOND PLATE;

STEP 2: SECURE THE DIAMOND PLATE WITH THE PROCURED FASTENERS, SEE FIGURE 1;

STEP 3: USE THE CLEAR SEAL AROUND THE DIAMOND PLATE TO PREVENT WATER FROM SEEPING UNDERNEATH SEE FIGURE 1;
