# TECHNICAL SERVICE BULLETIN

Technical Service Bulletin: 501-1704

Forest River is alerting you to an issue involving certain 2024 East to West Alta Travel Trailer Recreational Vehicles. Please see the information below, which describes the issue and provides you with details on the steps you should take to have your vehicle repaired.

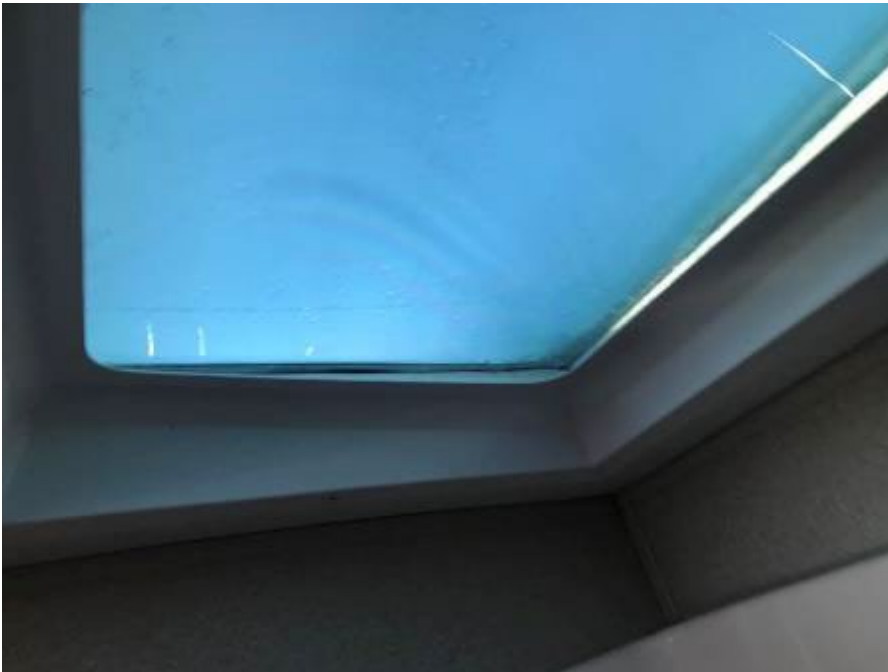
A limited number of outer dome skylights have displayed cracks soon after installation. Cracks may originate at the flange of the skylight and extend outward. This issue has been known to occur within 2 weeks of installation.

SAMPLE OF CRACKED SKYLIGHT

STEP 1: FROM THE ROOF SIDE OF THE UNIT, REMOVE THE COMPLETE SKYLIGHT;

STEP 2: PREPARE THE REPLACEMENT SKYLIGHT WITH BUTYL TAPE ON THE BOTTOM SIDE LIP SCREW FLANGE;

STEP 3: POSITION THE REPLACEMENT SKYLIGHT AND INSTALL THE SKYLIGHT TO THE UNIT USING 1 ¼ INCH SCREWS;

STEP 4: FINISH BY APPLYING SEALANT TO THE FLANGE OF THE REPLACEMENT SKYLIGHT OVERLAPPING ONTO ANY OF THE ORIGINAL SEALANT;
