Service Bulletin

Bulletin No.: 20-NA-120

Subject: Information on Malfunction Indicator Lamp (MIL) Illuminated - Multiple DTCs Set

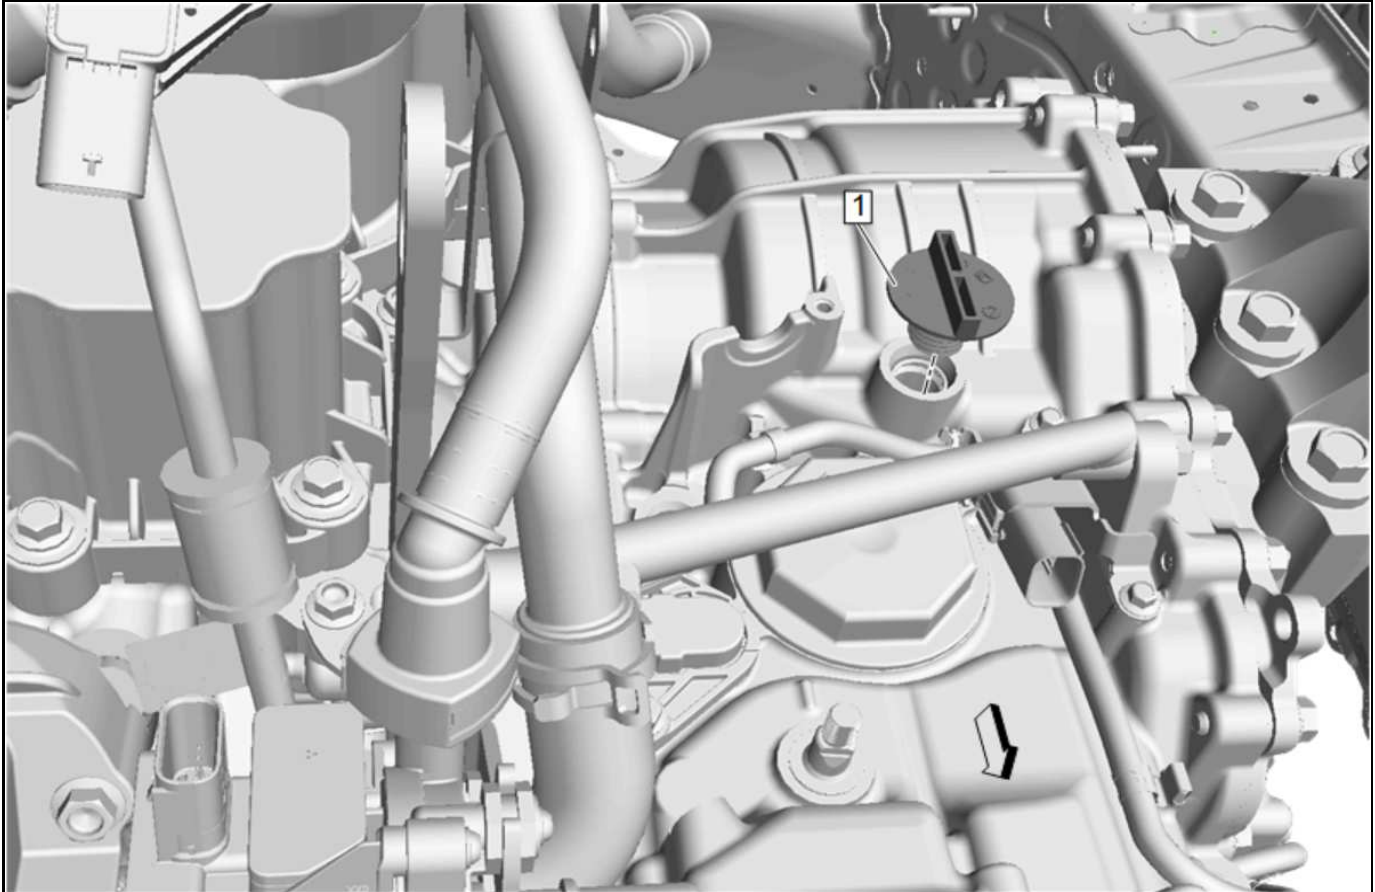
The pulley and chain can be accessed through the transmission fluid filler cap (1) at the top of the transmission.

1. Insert the borescope between the chain guard pivot and the inside edge of the primary pulley.

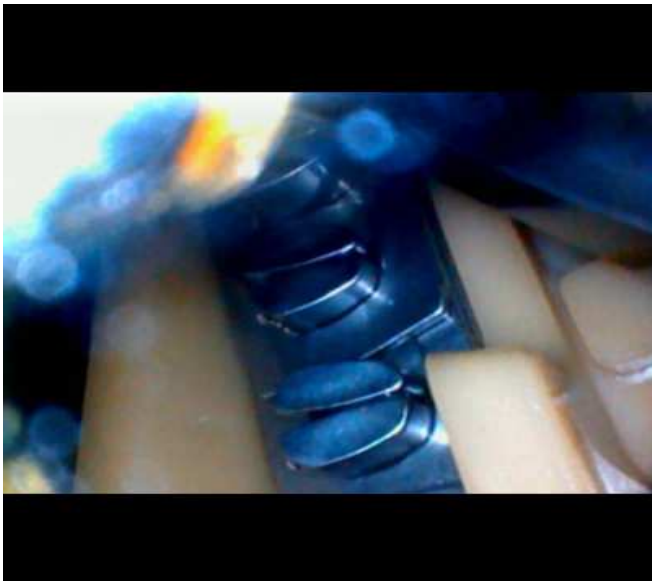
5608011

- If the pin ends have no signs of slip marks, the transmission is OK to be repaired for the cause of the DTC/low fluid level.

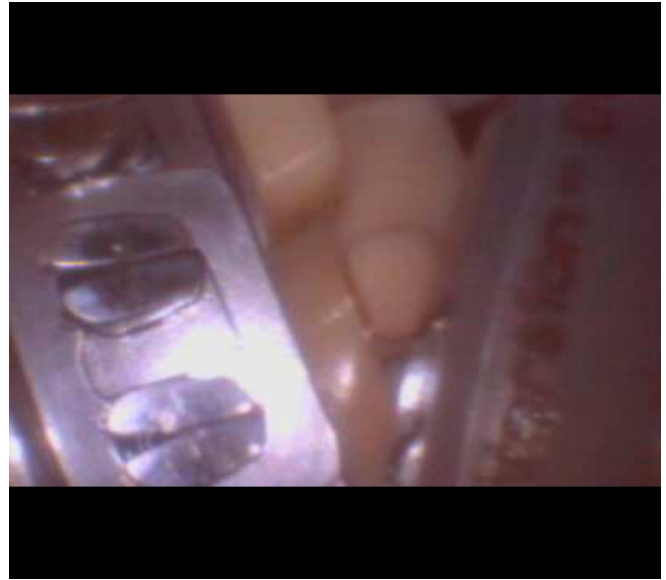
5608015

- If the pin ends have signs of slip marks, the transmission should be replaced, not repaired.
3. Inspect for a damaged pulley surface.
