SIM 61 02 23

GEAR SELECTOR SWITCH (GWS) BUTTONS OR INDICATOR LIGHTING MALFUNCTION

This Service Information Bulletin (Revision 1) replaces SI M61 02 23 dated **March 2023**.

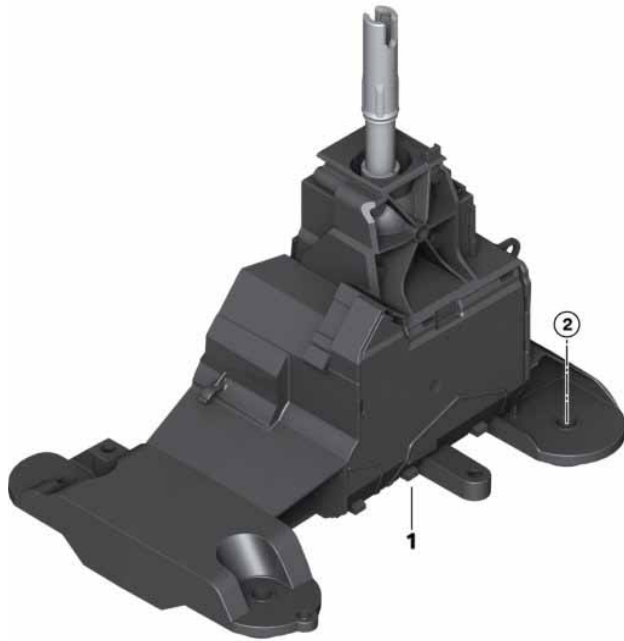
The buttons on the gear selector switch (GWS) do not work, or the function indicator lighting has failed.

Damage to the shift box (Selector Lever) ribbon cable

Replace the shift box (Selector Lever), then reassess the vehicle.

1. Perform a vehicle test using ISTA, read fault memory and diagnose any relevant faults.
2. Disconnect the 12 V vehicle battery.
3. Replace the Shift box (Selector Lever), refer to repair instructions **25 16 059** “Removing and installing/replacing shiftbox”.
4. Reconnect the 12 V vehicle battery.
5. Utilizing ISTA, clear any fault codes induced by the defective ribbon cable.
6. Perform a sleep cycle until the hazard warning switch light goes out, this can take up to 30 minutes.
7. Wake the vehicle and verify the effectiveness of the repair by testing the functionality of the GWS.

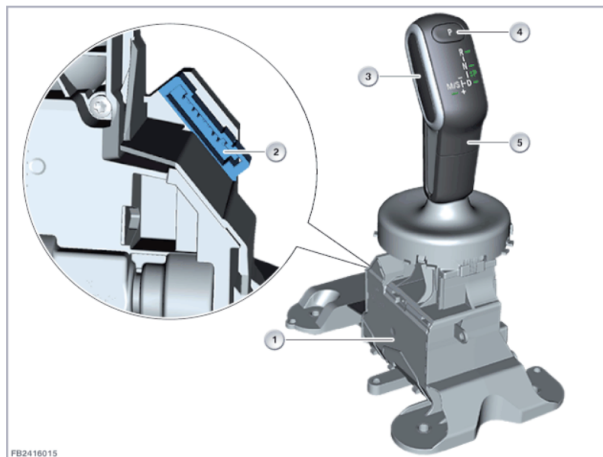
Does the GWS operate as designed? (Buttons, lighting, etc.)

- Yes:** No further action is necessary.
No: Further diagnosis with ISTA is needed.
