SIB 65 27 23

2023-11-20

APPLE CARPLAY® VARIOUS OPERATIONAL FAULTS

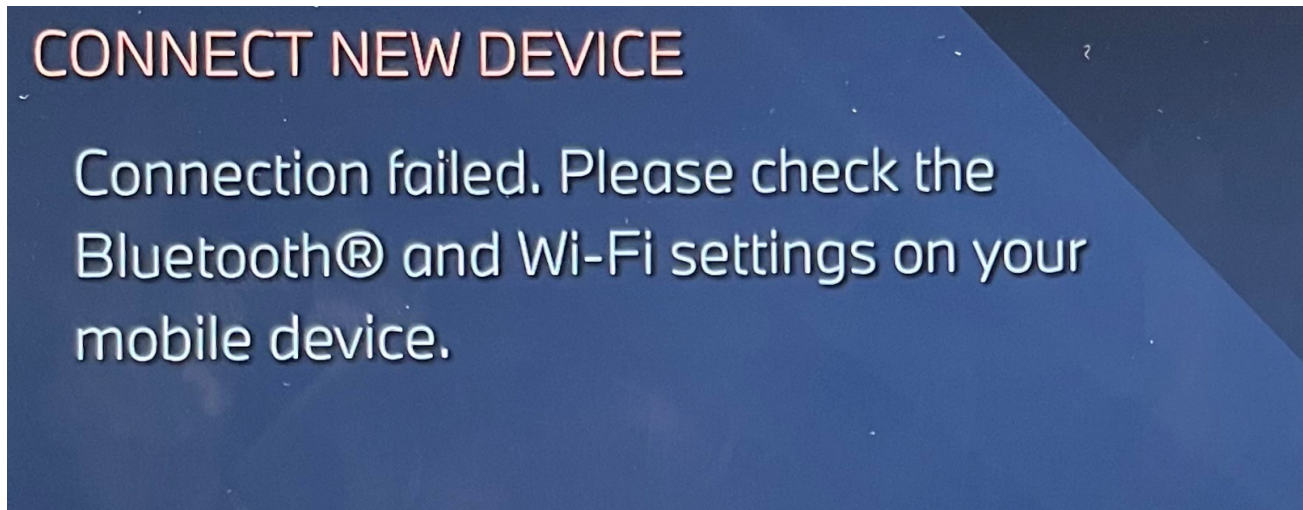
- No selections can be made in Apple CarPlay® using the I-Drive Controller
- Apple CarPlay® connections may intermittently be dropped and reconnected
- When connecting a mobile device using Apple CarPlay®, the following warning pop-up may be displayed

Unfavorable software in the head unit (HU-H5).

Program the head unit (HU-H5).
