SIM 51 16 16

2023-11-02

CAVITY PROTECTION WAX LEAKING OUT OF HOOD

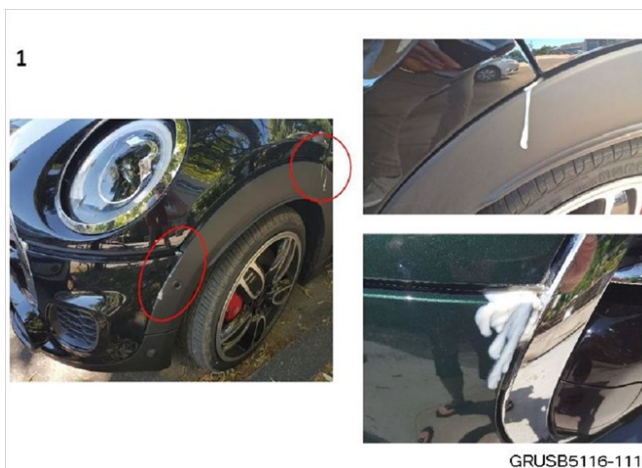
GRUSB5116-111

Cavity protection applied to underside of the hood is leaking out onto the wheel arch trim and grille.

Improper application of cavity protection wax during vehicle production.

Remove the current protection and reapply it more accurately.
