TECHNICAL INSTRUCTIONS

LIMITED SERVICE CAMPAIGN 22LD02

OPTIONAL BODY-COLORED REAR SPOILER DESIGNED FOR:

CERTAIN 2021 MODEL YEAR IS 300 VEHICLES

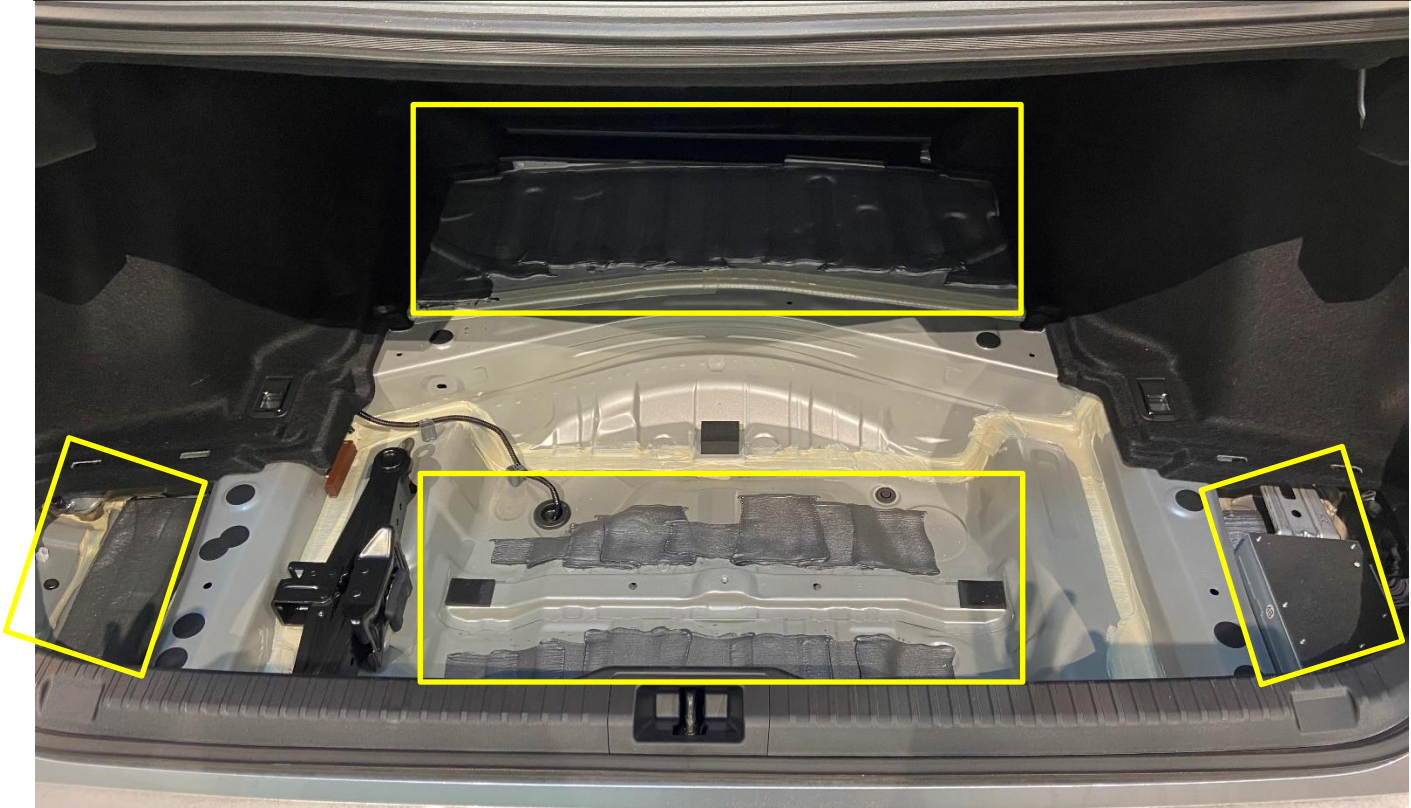
Organic Growth Inspection Areas

- a) Visually inspect the areas, shown below, for signs of organic growth caused by water intrusion.

NOTE: The areas shown immediately below are the most prone to organic growth because they are coated in factory applied LASD (liquid applied sound deadening).

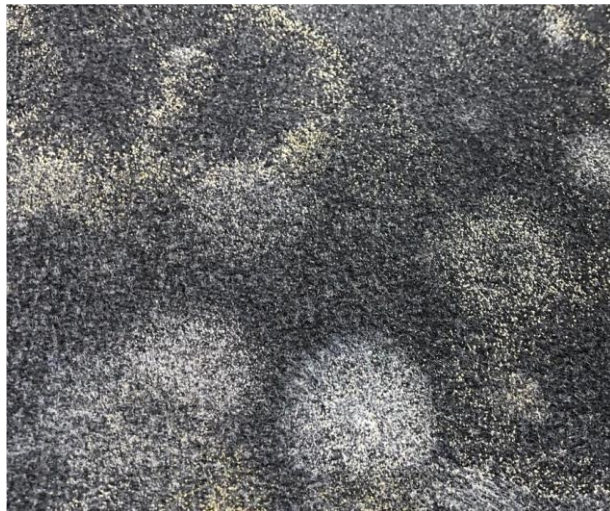
Example of Organic growth

11. **VISUALLY INSPECT TRUNK FABRIC LINER COMPONENTS FOR ORGANIC GROWTH**
a) Visually inspect the fabric liners, shown below, for signs of organic growth caused by water intrusion.

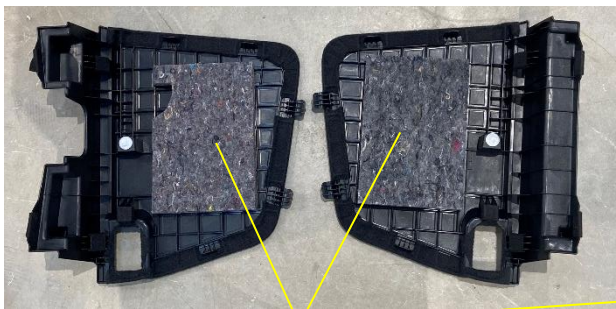
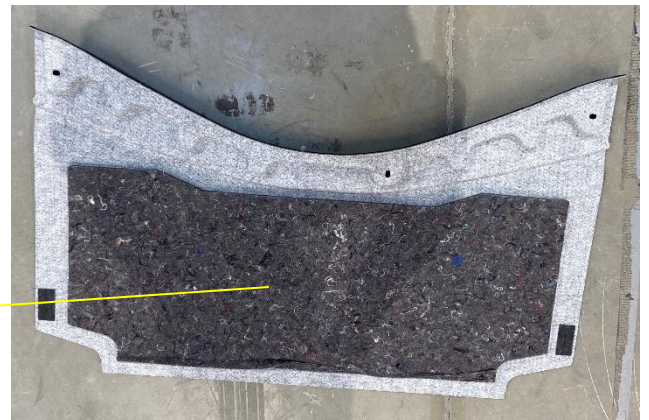
- b) Organic growth is most commonly found on the jute padding. But you should inspect both sides of the panel

Organic growth is most commonly found on the jute padding
