# Technical Service Bulletin

## 90 Error message "CBR1021E: Can't parse Request. (cpngw)" when adapting control units, keys or immobilizer, B201700

90 23 50 2072005/1 November 6, 2023.

Model(s)	Year	VIN Range	Vehicle-Specific Equipment
A4, A4 allroad, and Q7	2017	All	Vehicle Services through Connected Gateway

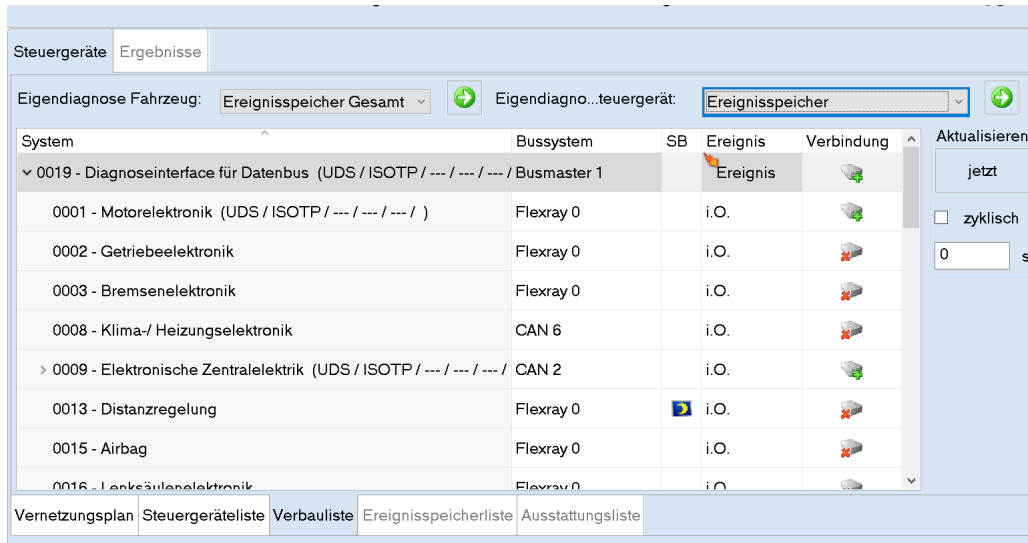
**Figure 1. Self Diagnosis Identification**

1. Scan the vehicle using self-diagnosis to determine if the VIN number is readable in the extended identification in the Gateway (address word 0019). To do so, proceed as follows:
  - a. Open the vehicle self-diagnosis.
  - b. Select "**0019 – Data Bus On Board Diagnostic Interface**" and then use the drop-down menu (top right) to select **Identification**. (Figure 1).

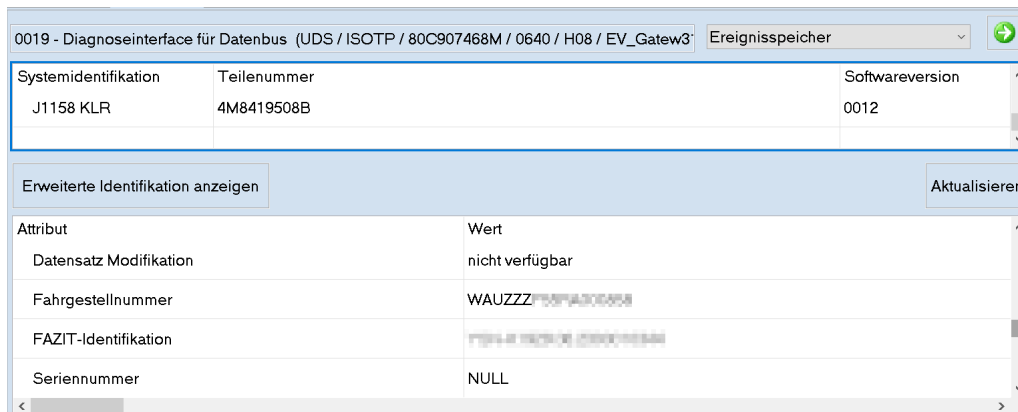
**Figure 2. VIN Number**

2. Open the identification for the Data Bus On Board Diagnostic Interface with the green arrow.
  - a. Scroll down to the VIN number. (Figure 2).

3. If the VIN number displayed is partly made up of symbols, this TSB applies. In this case, replace the Gateway control module, J533.
4. If the VIN number displayed is correct for the vehicle, this TSB does not apply. Replacing the data bus diagnostic interface will not fix the problem. Proceed with standard diagnosis.
