Title: Baseline 1065/1066 Update**Applicability:** MY20 Revero GT and GTS,
and MY21-MY23 GS-6 vehicles**PRIORITY:** Vehicles on list (page 2)**PURPOSE:**

Type: Baseline Release

System: General Diagnosis

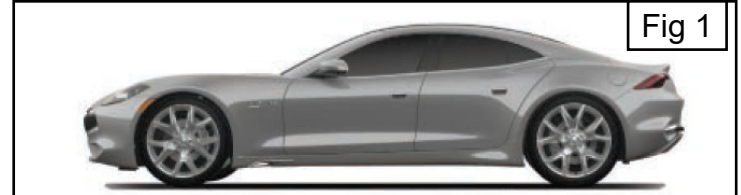
Keep the hood closed when doing a Baseline update for all Revero GT or GTS, and GS-6 (Fig 1). Do not have a charger on the vehicle, unless prompted during the update.

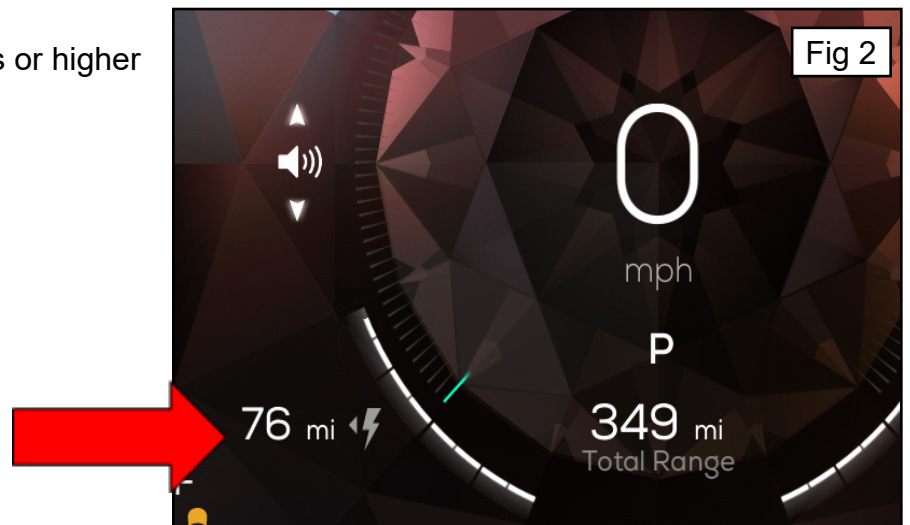
Ensure the electric range is at 25 miles or higher in the displayed range gauge (Fig 2).

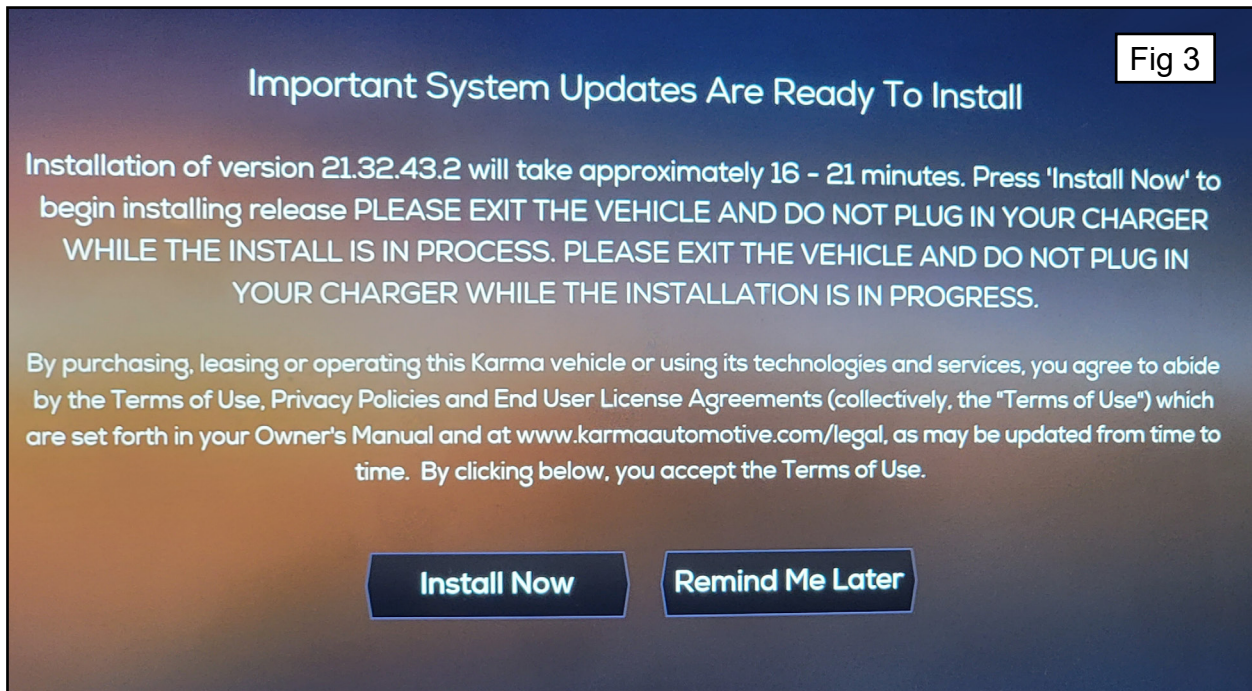
Accept the prompt to perform the OTA, install, do not allow the vehicle to “sleep”. Leave a door open, this is a easy way to prevent this (Fig. 3).

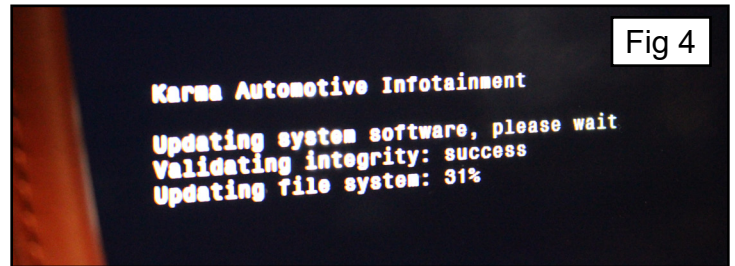
The Touch Panel screen will display the step it is involved in from downloading to install. The vehicle will reboot when complete, see below (Fig 4).

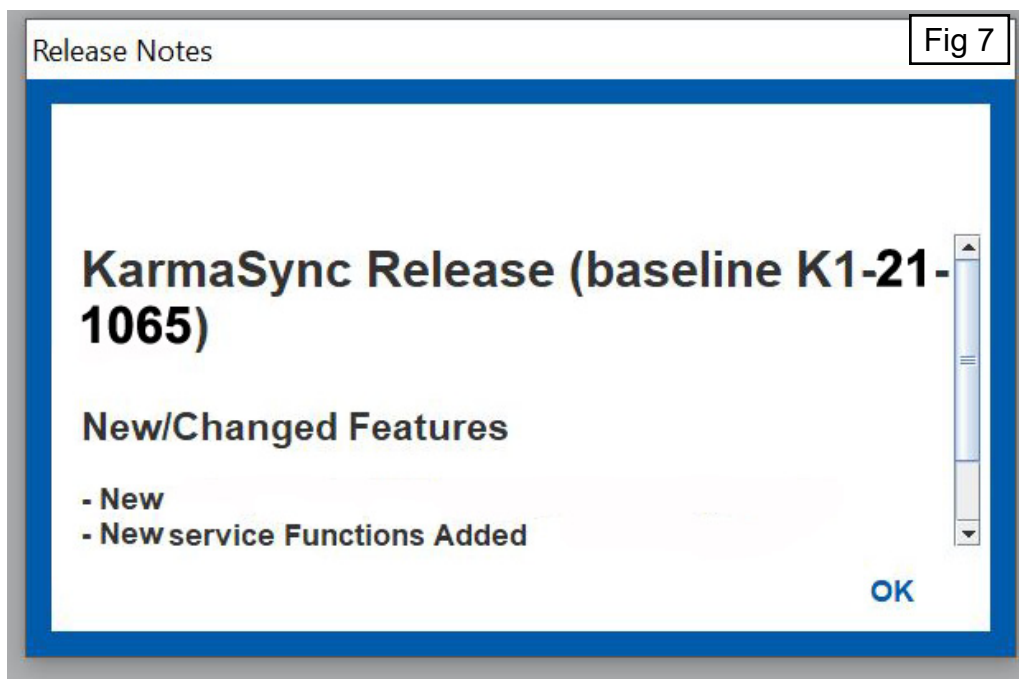
The Karma Sync should be updated to the latest deliverable, this message will be displayed when the initial session is launched (sample image in Fig 7), no action on Karma Sync is required other than clearing any Trouble codes present if necessary.

This step may require techline assistance if it does not complete, be sure to attempt the update first.

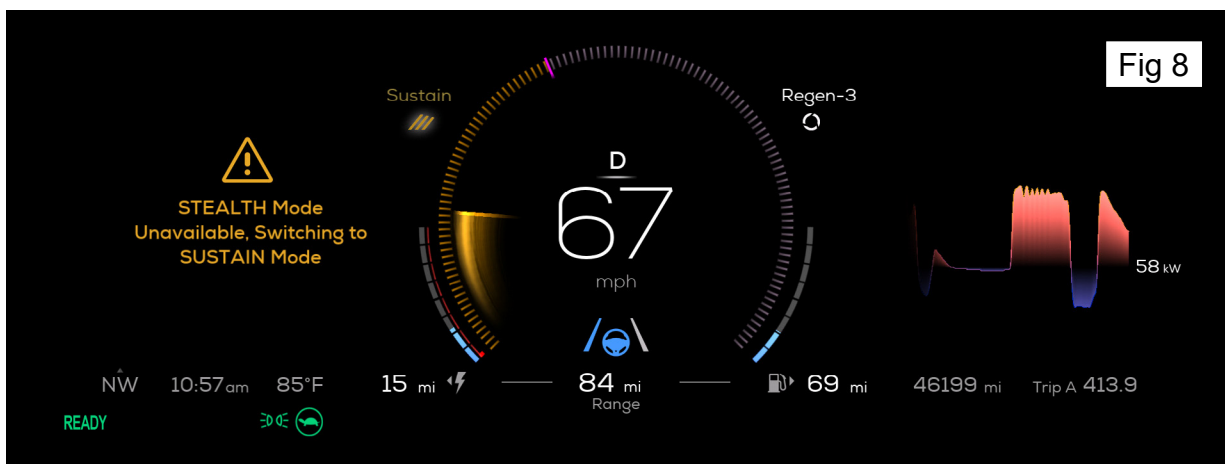
During high demand of energy from the vehicle, should the battery buffer be “degraded” it may be not possible to continue in Stealth or pure EV mode, until the conditions are met.

The vehicle may not allow Stealth mode to be engaged and will force Sustain mode (or Sport if chosen by the driver as of the new “Baseline 1065” release).

Also note the turtle telltale is illuminated! (Fig 8)

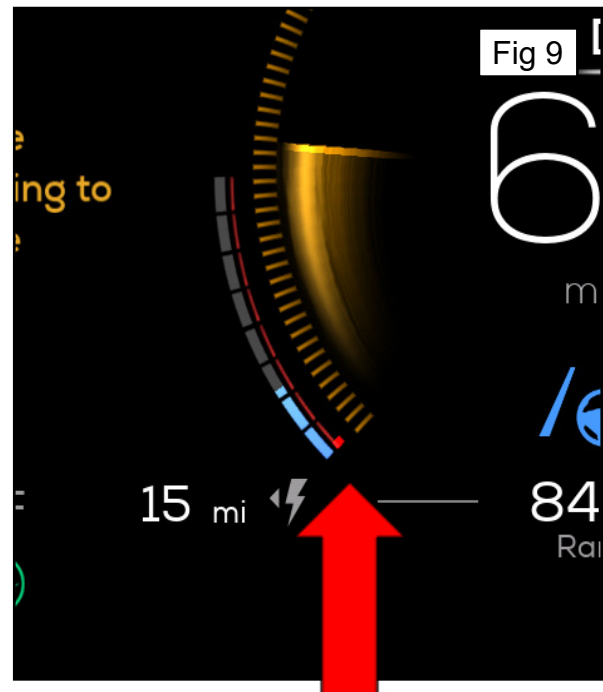
Here you can see the buffer in detail. The bar on the speedometer next to the HV battery charge level (Fig 9) you can see the available on demand, on the yellow sweep rising and the battery buffer being depleted, in red.

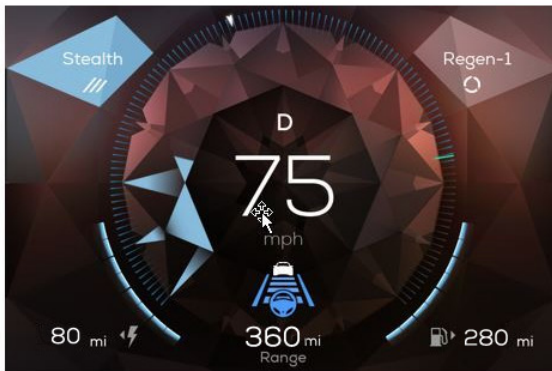
Battery Buffer Stages - FULL

On the diamond back ground DIS, the buffer is in the same location (Fig 10). The Battery Buffer can be seen next to the HV Battery Charge level, here in each image you can see the battery buffer go down to the level where the turtle icon will illuminate and the vehicle will force Sustain mode (engine on).

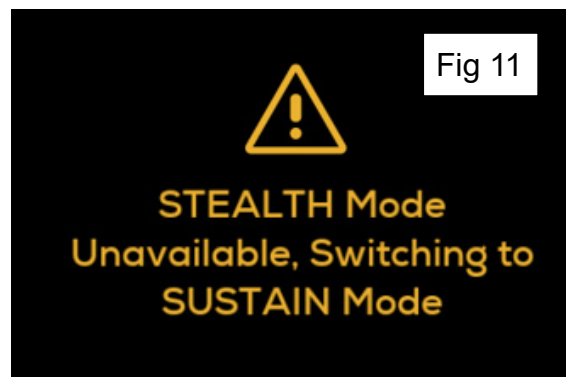
This message (fig 11) will be seen briefly, the turtle should remain until the condition is improved.
