Service Bulletin

Bulletin No.: 18-NA-375

Subject: Information on Diagnosis of No Start, Smoke/Fire Originating from Trunk, Radio Click Noise or Inoperative, Malfunction Indicator Lamp (MIL) Illuminated, and/or Various Electrical Issues

Brand:	Model:	Model Year:		Build Breakpoint Date:		Engine:	Transmission:
		from	to	from	to		
Chevrolet	Camaro	2016	2024	—	—	All	All

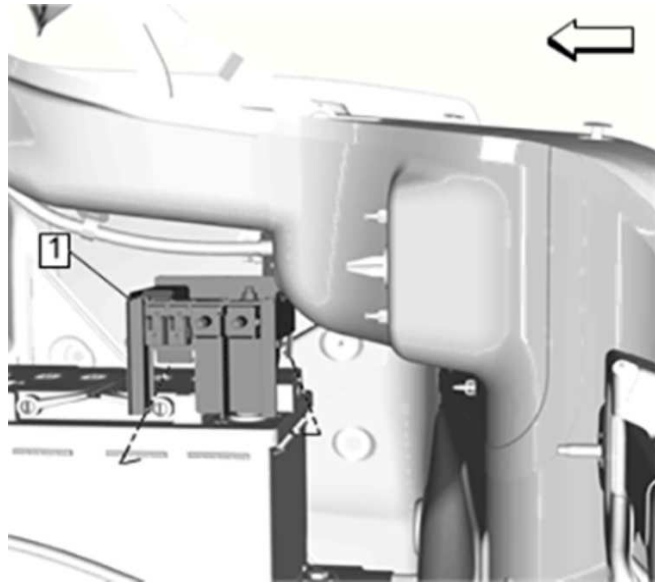
</div> <p style="text-align: right;">5187163</p> <p>Technicians may find water intrusion related damage at the rear body fuse block (1).</p>

<p>Correction</p>	<p>To determine the source of water intrusion, water test and inspect the following areas:</p> <ul style="list-style-type: none"> • Rear compartment lid weatherstrip area • Rear body structure stop lamp pockets • Rear body structure stop lamp foam missing • Seams around rear window • Sunroof drain hose disconnected or damaged • Missing or not fully seated body plugs (2 plugs located below the rear window on convertibles) <p>Note: If no water leaks are detected in any of the areas listed above, the water leak could be caused by the deck lid not being fully closed, ice melting or liquids being spilled inside the trunk area.</p> <p>If the source of the water leak is determined to be caused by one of the above conditions, repair the damaged/corroded wires and/or parts using the appropriate service procedure(s) referring to Service Information (SI).</p> <p>In addition, complete the Service Procedure outlined below.</p>
