# Service Bulletin

CRF1100A/A4/D/D4 #1  
Revised November 2023

## WARRANTY EXTENSION

### 2020 ~ 2022 CRF1100A/A4/D/D4 AFRICA TWIN MULTI-INFORMATION DISPLAY TOUCHSCREEN

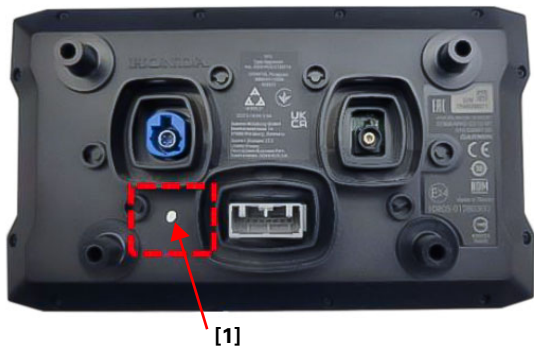
A countermeasured multi-information display can be identified by a white permanent paint mark [1] on the back of the display, as shown.

If the repair has already been done before, and a failure of the countermeasured part is confirmed, contact Techline to report it.

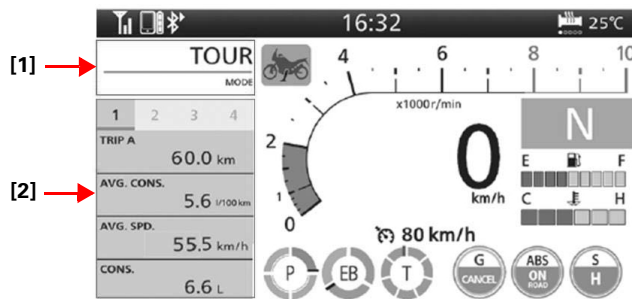
If the customer complains that the MID touch function does not respond, the riding mode switches unexpectedly, and trip data resets, inspect the touchscreen using the following information.

The touchscreen failure will only occur while the engine is running and the motorcycle is not moving (0 mph, 0 km/h). The MID is still operable by the left handle switch.

1. Check that the display does not respond to touch.
2. Check to see if the contents of the Riding Mode [1] and Sub-information indicator [2] in the MID changes unexpectedly, or the trip data resets.

If any of the symptoms above apply, replace the MID following the repair procedure and parts information shown in this bulletin.
