# Service Bulletin

Bulletin No.: 22-NA-256

**Subject: Cluster Graphics Programming Failure**

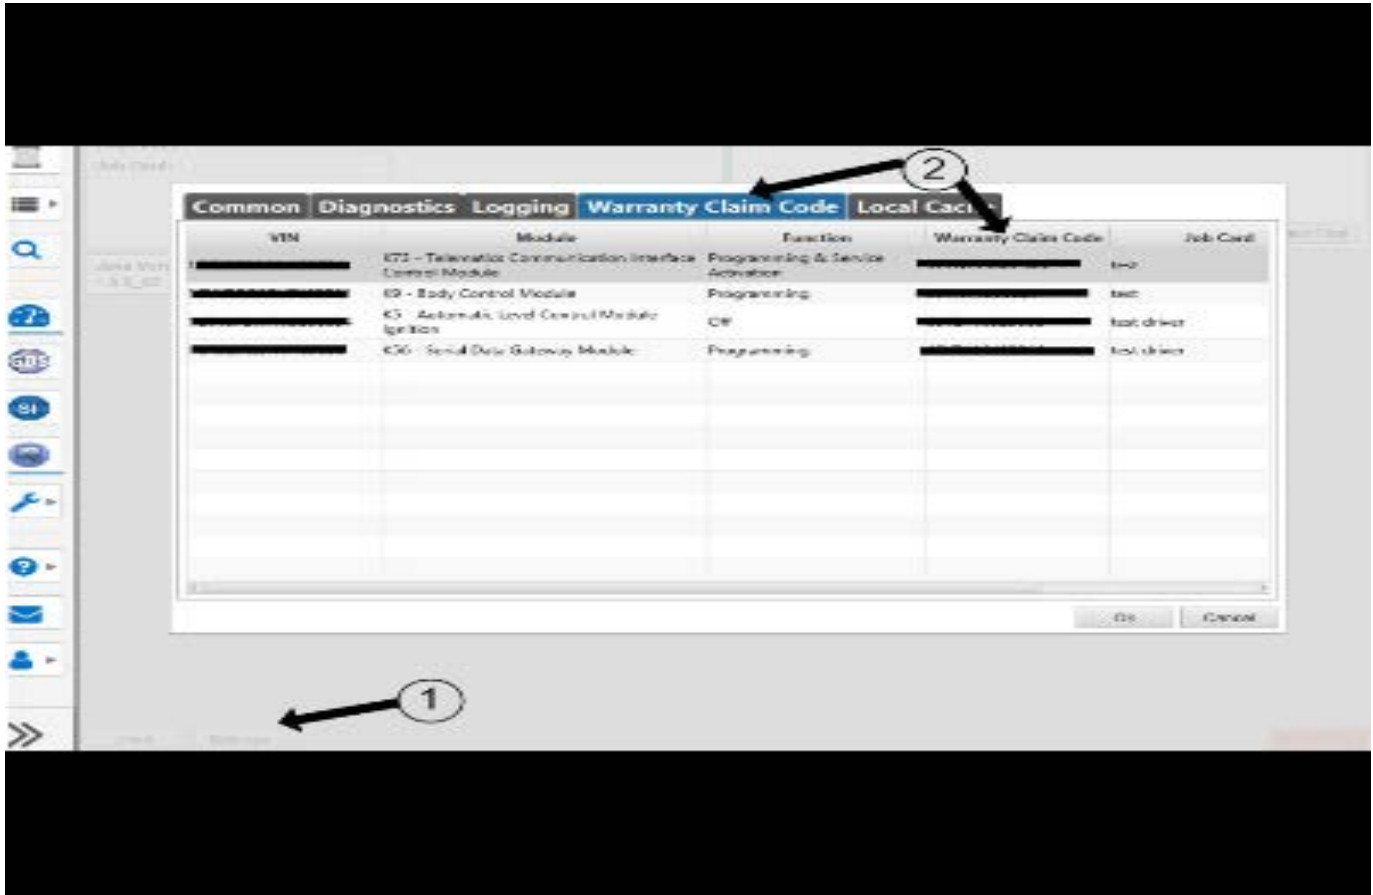
6125774

If the Warranty Claim Code was not recorded on the Job Card, the code can be retrieved in the SPS2 system as follows:

1. Open TLC on the computer used to program the vehicle.
2. Select and start SPS2.
3. Select Settings (1).
4. Select the Warranty Claim Code tab (2).
