Service Bulletin

Bulletin No.: 23-NA-058

Subject: Cold Start Rattle Noise from the Engine Compartment, Malfunction Indicator Lamp (MIL) Illuminated - DTC P0299 Set

Brand:	Model:	Model Year:		VIN:		Engine:	Transmission:
		from	to	from	to		
Buick	Encore GX	2020	2023			1.2L (LIH)	
Chevrolet	Trailblazer	2021

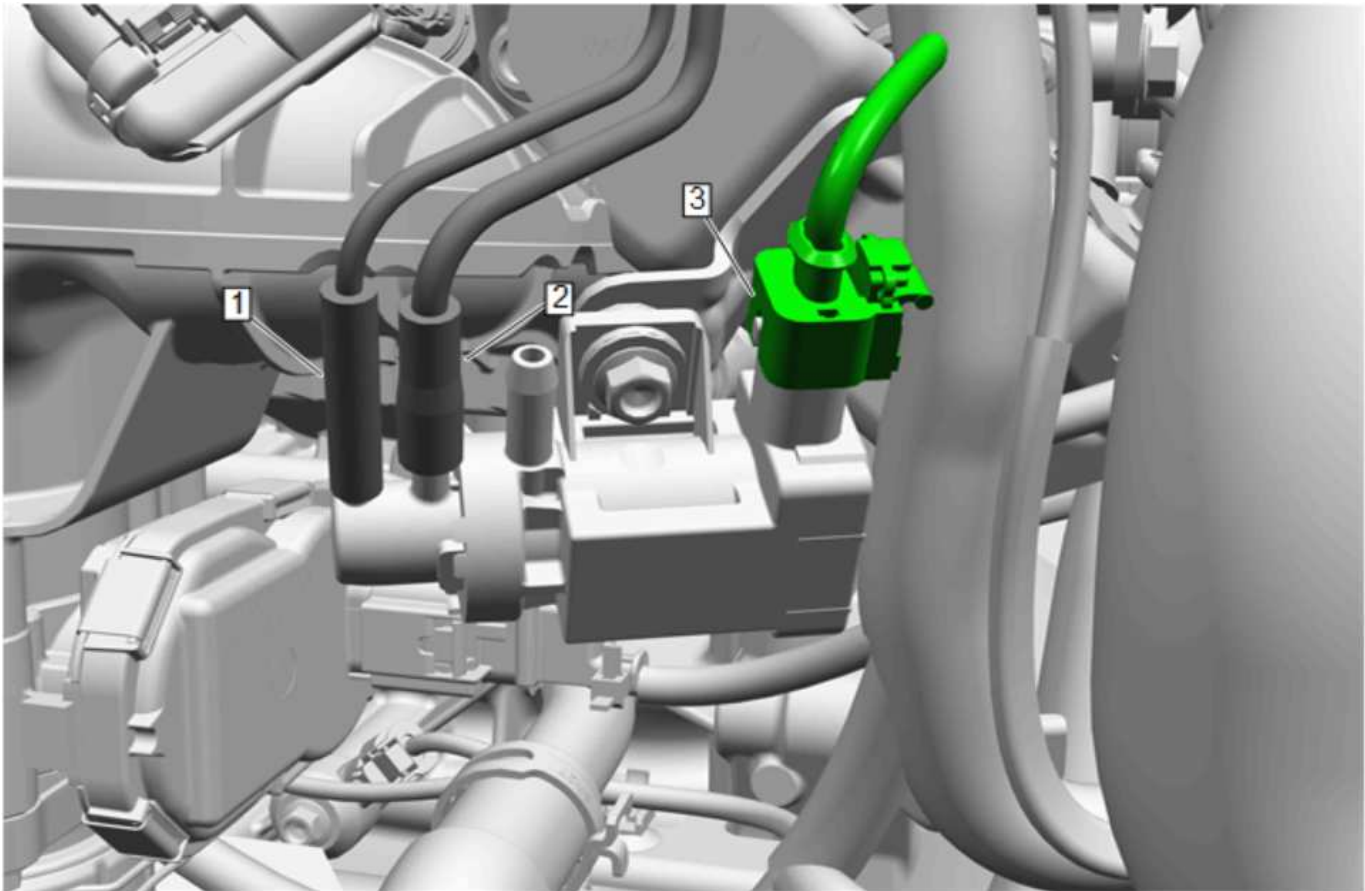
5392518

Check Vacuum Supply from the Vacuum Pump

1. Disconnect the Turbocharger Wastegate Actuator Vacuum Control Solenoid Valve Hose (1) from the Turbocharger Wastegate Regulator Solenoid Valve.
 2. Utilizing EN-23738-A Vacuum Pump with an integral vacuum gauge, connect said pump to the Turbocharger Wastegate Actuator Vacuum Control Solenoid Valve Hose.

3. Engine at operating temperature at idle.
 4. Verify the tool reading: EN-23738-A Vacuum Pump = -50 kPa (-0.5 bar, 15 in Hg).
 - If the desired pressure/vacuum cannot be achieved or does not hold steady:

- ⇒ Ignition/Vehicle » Off.
- ⇒ Test or replace the component: Vacuum Pump Assembly and related hoses.
- If the desired pressure/vacuum can be achieved and holds steady:

- Engine » Off.
 - Reconnect the Turbocharger Wastegate Actuator Vacuum Control Solenoid Valve Hose to the Turbocharger Wastegate Regulator Solenoid Valve and refer to Check Wastegate Vacuum Regulator Valve Function.
