Service Bulletin

Bulletin No.: 23-NA-128

Subject: Noise from Roof Area at Speeds 35 MPH (56 km/h) and Above

Brand:	Model:	Model Year:		VIN:		Engine:	Transmission:
		from	to	from	to		
GMC	Acadia	2017	2023	-	-	All	All

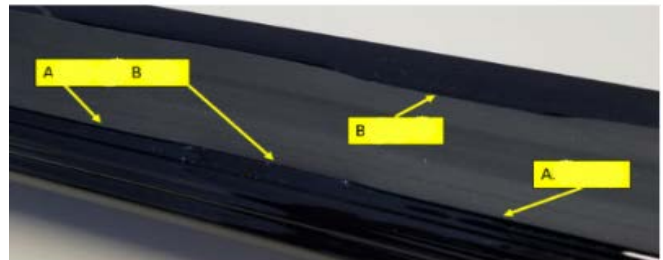
6388145

- AB = Above Bar and Below Bar
- A = Above Bar
- B = Below Bar

If you encounter a vehicle with the rub strip above, above and below, or appears to be sitting on top of the cross bar as seen here, follow the rub strip replacement procedure below:

1. Remove affected Cross Bar from vehicle.
2. Place Cross Bar assembly on work bench.

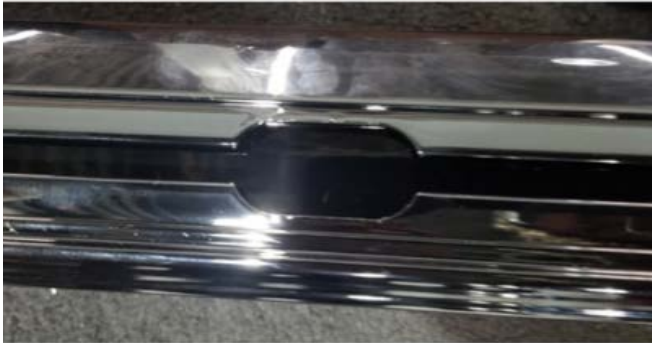
6388147

3. Locate the center of the top of the bar where there is a rectangular opening under the rub strip.
