**HYUNDAI**
Technical Service Bulletin

GROUP BRAKES	NUMBER 23-BR-004H
DATE NOVEMBER 2023	MODEL(S) TUCSON (NX4A) SANTA CRUZ (NXT) SANTA FE (TMA) SANTA FE HYBRID (TMA HEV)

SUBJECT: BRAKE INSPECTION AND SERVICE PROCEDURE

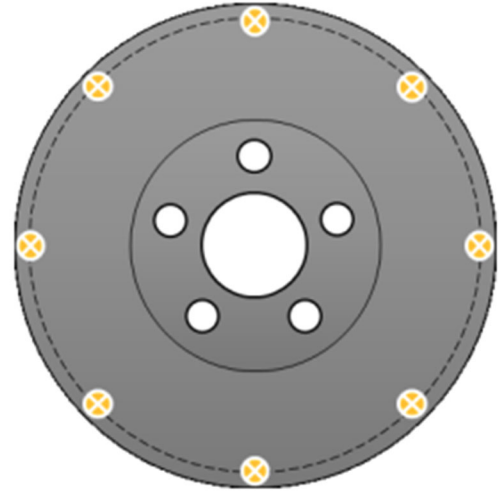
- Refer to the applicable vehicle shop manual for minimum thickness.
- When measuring the brake rotor for minimum service thickness and runout, remove all surface contamination and corrosion to ensure an accurate measurement.
- Measure the thickness at 8 points (every 45 degrees) around the rotor, 5-10mm or 0.2-0.4" inboard of the outer edge. Record these measurements on the repair order sheet.

Measurement locations around rotor

1. Measure rotor thickness and determine if rotors should be machined or replaced. If machined, measure both **BEFORE** and **AFTER** machining to ensure the brake rotor is within specification.

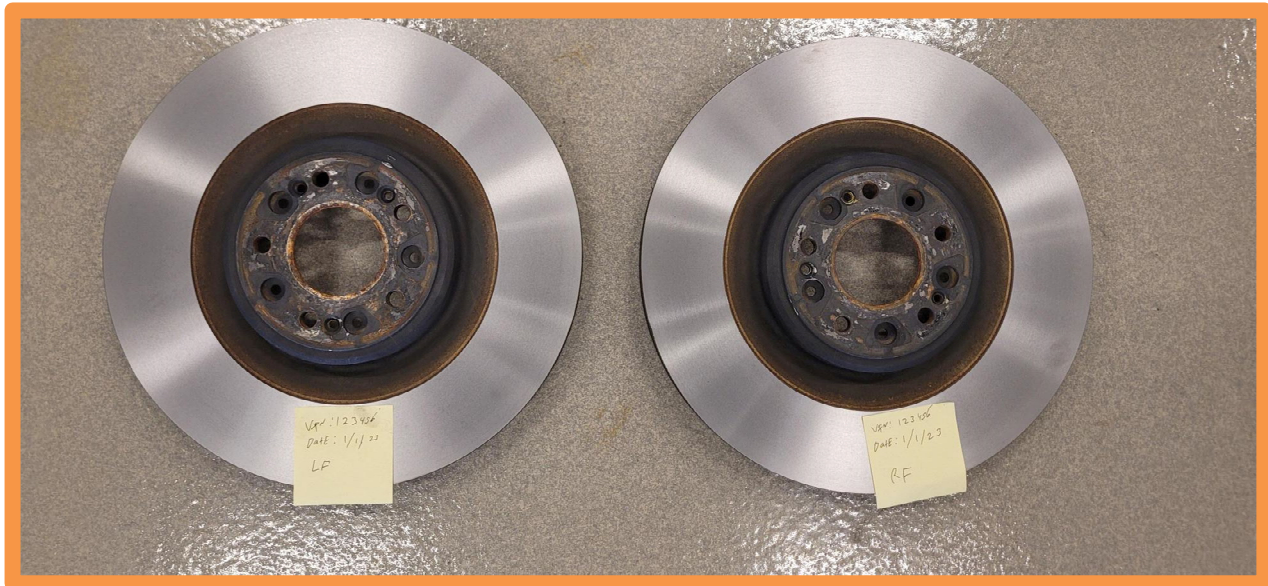
Using STUI, take clear photos of freshly resurfaced or new brake rotors (both left and right) with the last 6 digits of the VIN and the date of repair on a piece of paper. Photo(s) can be rotors off the vehicle, or on the vehicle. If on the vehicle, submit both left and right photos individually. See example shown below.

Upload photo(s) to STUI.
