HYUNDAI Technical Service Bulletin	GROUP AUTOMATIC TRANSMISSION	NUMBER 23-AT-006H-2
	DATE NOVEMBER 2023	MODEL PALISADE (LX2) SANTA FE (TMA) SANTA FE HYBRID (TM/TMa HEV) SONATA (DN8A) SONATA HYBRID (DN8 HEV) TUCSON (NX4/NX4A) TUCSON HYBRID (NX4 HEV)
SUBJECT: AUTOMATIC TRANSAXLE PUSH-BUTTON SHIFTER DIAGNOSIS

This TSB supersedes TSB 23-AT-006H-1 to add additional information regarding harness damage repair for Tucson (NX4A), Step 6.

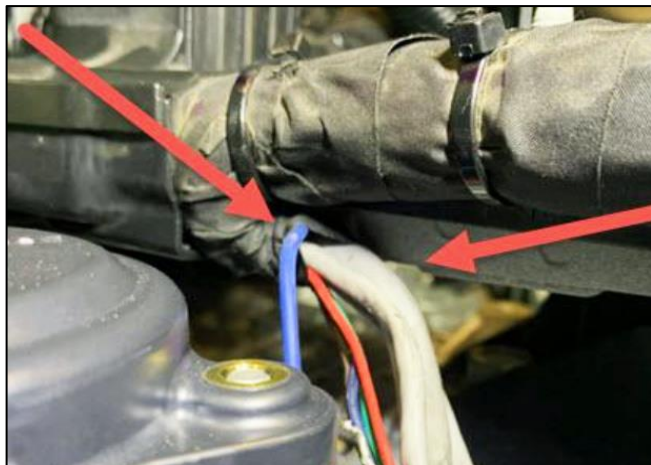
Santa Fe (TMa) 2.5L – VINs begin with 5NM:
Carefully unwrap the harness protector in the area shown below. Check the insulation on the wires to see if the insulation has been damaged by contact with the battery tray. If so, repair or replace the control harness.

If replacing the control harness, make sure the replacement harness does not contact the battery tray or other components. Otherwise, the harness may become damaged again.

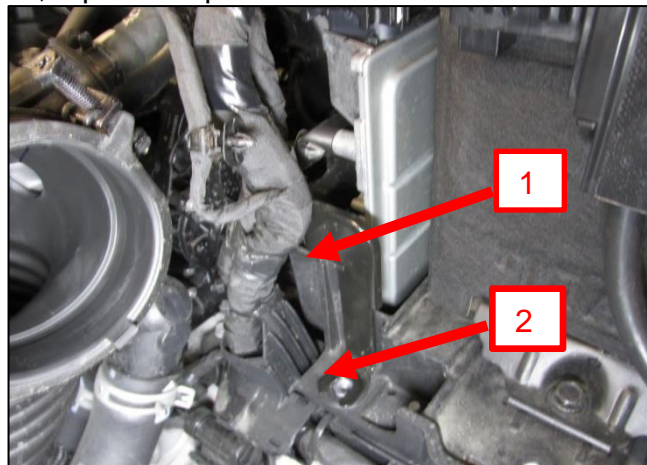
Tucson (NX4/NX4A) 2.5L–VINs KM8 or 5NM:
Carefully unwrap the harness protector in the areas shown below:

- 1. NX4 (KM8):** Check if the insulation has been damaged by contact with the metal bracket.
- 2. NX4A (5NM):** Check for broken wires in the area of the 90 degree bend in the harness. If so, repair or replace the control harness.
