Service Bulletin

Bulletin No.: 23-NA-163

Subject: No Crank, No Start, Quick Start/Stall, No FOB Detected, Key FOBs Inoperative, B3924 00, B3925 00, B3926 00, B3927 00, B3928 00 Set

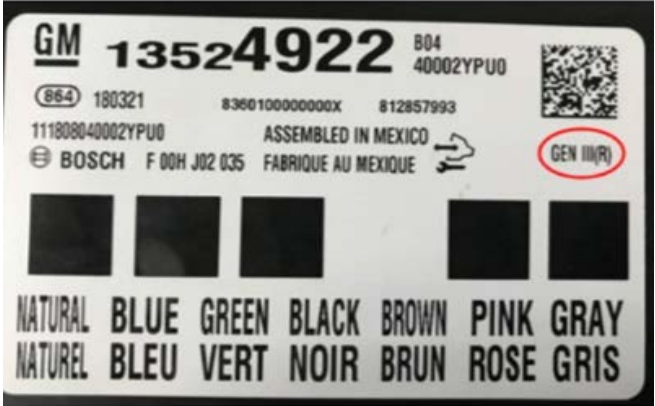
6482605

Involved Region or Country	North America. Middle East
Condition	<p>Some customers may comment that the vehicle will not crank or will start but immediately stall and/or the key FOBs are inoperative.</p> <p>The BCM may have set DTC B389A 00, and it is current. (If there is no DTC B389A 00, disconnect/reconnect battery for a minimum of 30 seconds and check again for DTC B389A.) With DTC B389A 00 current, it will have three or more of the following Environment ID DTCs (B3924 00, B3925 00, B3926 00, B3927 00) current in the BCM.</p>
Cause	<p>The cause of the condition may have presented immediately following a low voltage condition, jump start, battery charging, battery replacement or battery disconnect and reconnect. This can present a memory corruption event in the BCM.</p>
Correction	<p>Important: Do not attempt the immobilizer procedure or module replacements before following this bulletin.</p> <p>Resolve any current U-code DTCs by following standard troubleshooting procedures.</p> <p>This procedure ONLY applies to the GEN3R BCM.</p> <p>GEN3R BCMs can be identified by either the label on the module or looking up the BMPN part number information in GDS2.</p> <div style="text-align: center;">

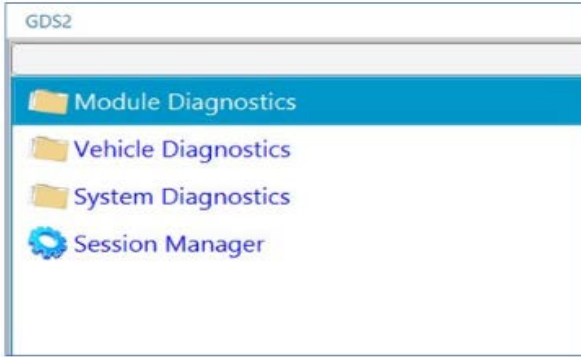
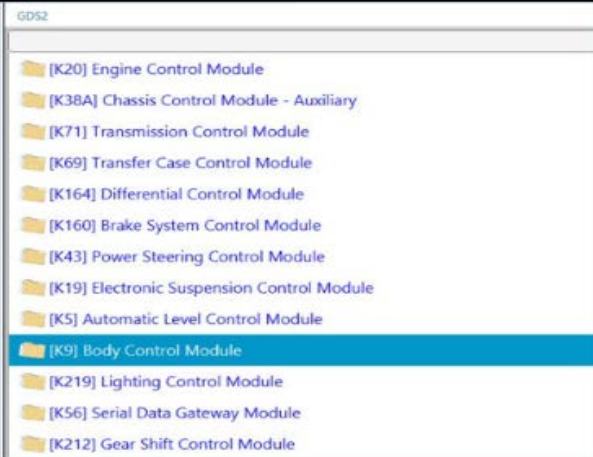
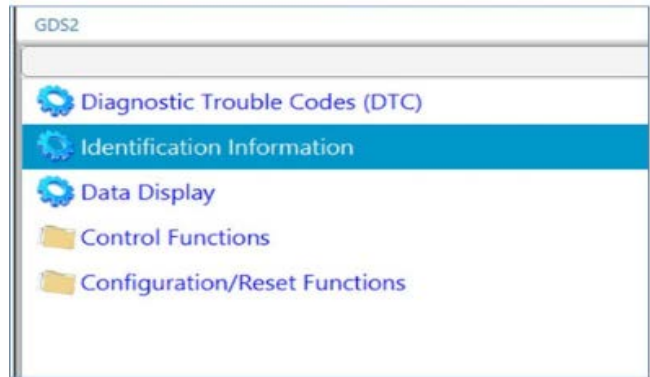
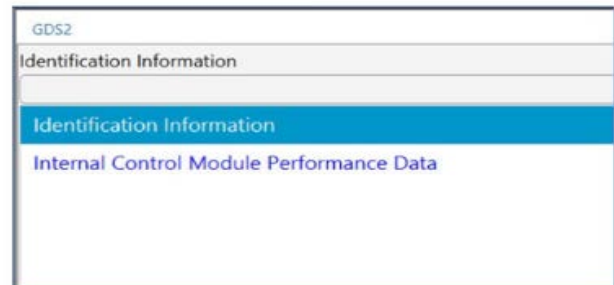
Verify you have a GEN3R BCM Base Model Part Number. Only GEN3R BCMS are eligible for this bulletin. Navigate to GDS2 > Module Diagnostics > [K9] Body Control Module > Identification Information > Identification Information.
