**HYUNDAI**
Technical Service Bulletin

GROUP CAMPAIGN	NUMBER 23-01-085H-1
DATE NOVEMBER 2023	MODEL(S) TUCSON (NX4A) SANTA CRUZ (NXT)

SUBJECT: WINDSHIELD WATER LEAK REPAIR (SERVICE CAMPAIGN 9A6)

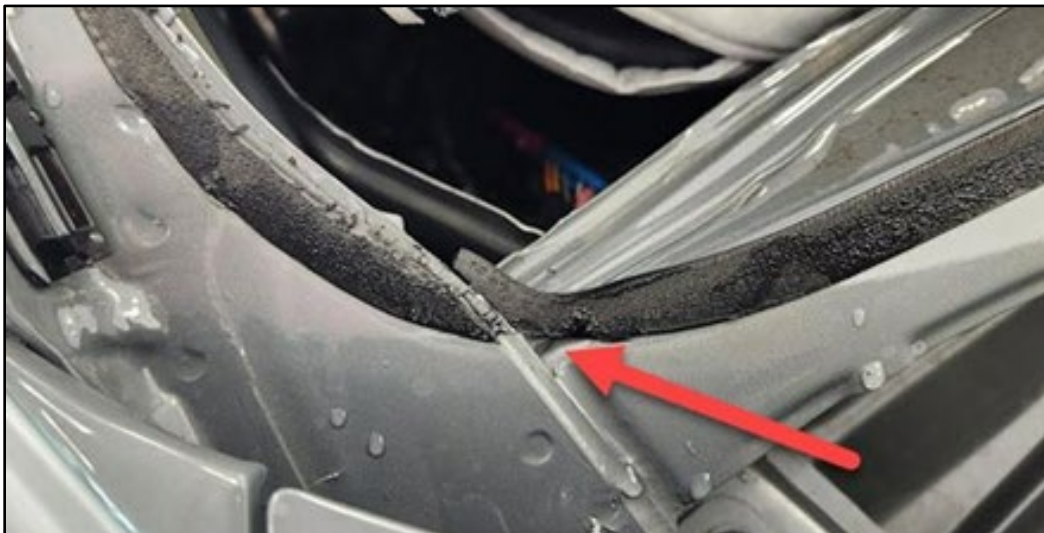
Description: Certain 2024MY Tucson (NX4A) and Santa Cruz (NXT) vehicles may exhibit water intrusion in the front passenger cabin from improper sealing of the windshield glass. This bulletin provides the procedures to fill in the gap of the urethane seal between the body and windshield glass.
