# RCA-60-23-001-1: Improved Fender Liner and Front Subframe Underbody Panel Clearance

<b>Document Type</b>	Customer Satisfaction Campaign Bulletin
<b>Date</b>	November 8, 2023
<b>Affected Region(s)</b>	USA
<b>Affected Model(s)</b>	R1T
<b>Model Year(s)</b>	2022
<b>Approximate Build Dates</b>	August 2021 - December 2021

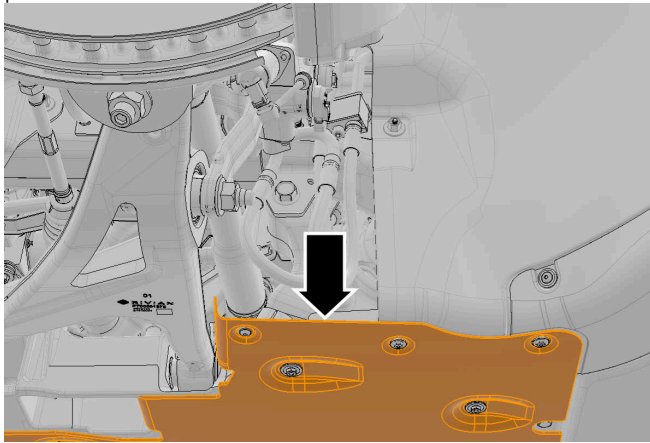
1. Raise and Support Vehicle (refer to service manual procedure 981020017).
2. On both sides of the vehicle: Inspect the highlighted component for a notch in the indicated area.
  - If there is no notch: Replace: Panel, Underbody, Front Subframe (refer to service manual procedure 606515010).

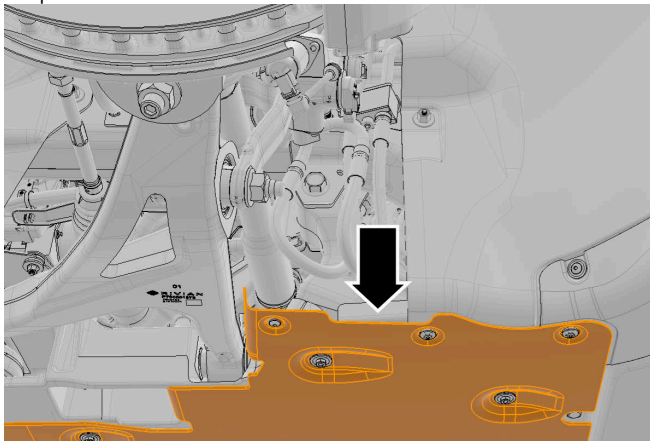
- If there is a notch: The underbody panel does not need to be replaced. Continue to the next step.

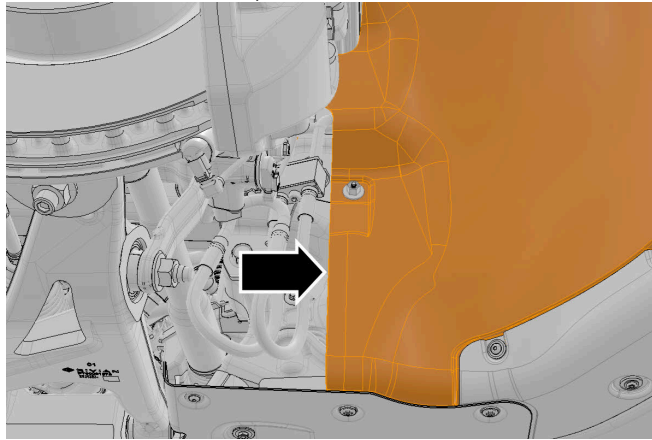
3. On both sides of the vehicle: Inspect the highlighted component for a notch in the indicated area.
  - If there is no notch: Replace: Liner, Wheel, Front (refer to service manual procedure 607610010).

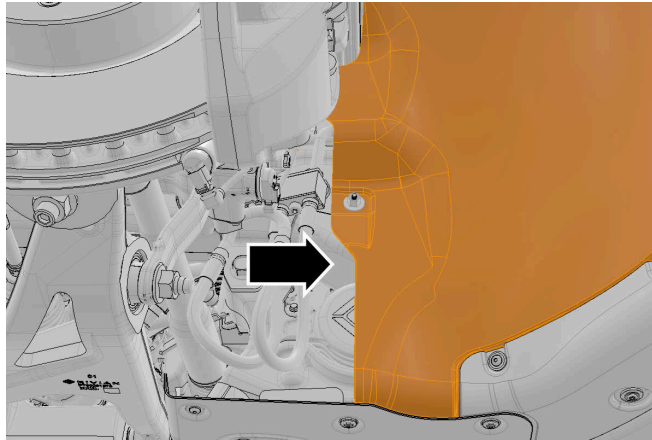
- If there is a notch: The fender liner does not need to be replaced. Continue to the next step.
