Technical Service Bulletin

96 High beam assist or traffic sign detection limited, DTC C12B3FD may be stored in the DAS control module

69 23 01 2059201/7 November 15, 2023. Supersedes Technical Service Bulletin Group 96 number 23-85 dated April 13, 2023 for reasons listed below.

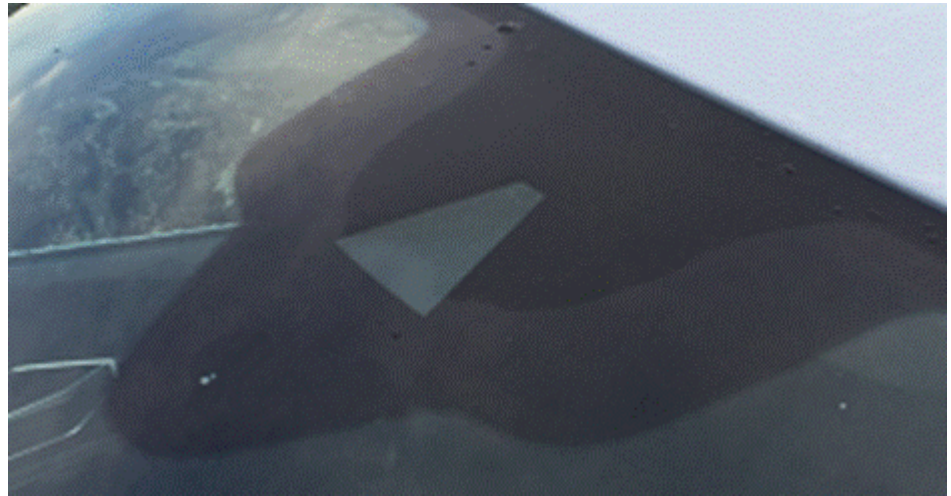
The viewing area of the front camera can be fogged up both on the inside and/or on the outside (Figures 1 - 2).

Figure 1. Viewing area fogged up from outside.

3. The customer cannot see this from the interior of the vehicle. Often it is enough to switch on the wiper system to fix the concern.
4. If the front camera is fogged up from the inside regularly, it can help to remove its lens hood in order to clean and dry the viewing area of the camera.

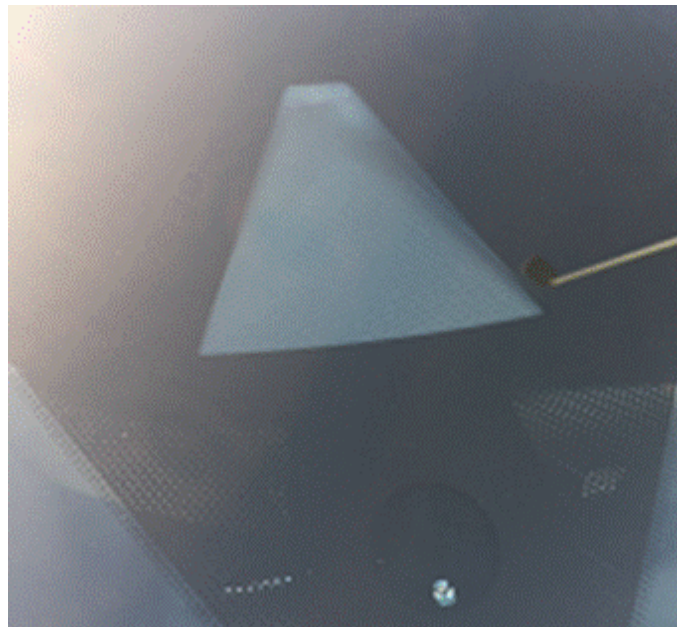
Figure 2. Viewing area fogged up from inside.
