69 Airbag warning light on, difficult to activate horn, B120E11, B100011 69 23 03 2072076/1 November 17, 2023.

Model(s)	Year	VIN Range	Vehicle-Specific Equipment
A3, S3, and RS 3	2022 – 2024	All	Not Applicable

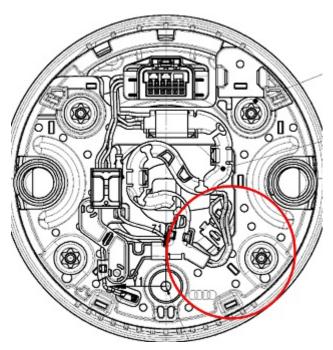
Figure 1. Inspect wire harness for damage and routing in the circled area.

- 3. Replace the driver airbag wire harness and observe the cable routing when reinstalling the driver airbag.
- 4. After reinstalling the driver airbag, clear all fault codes.

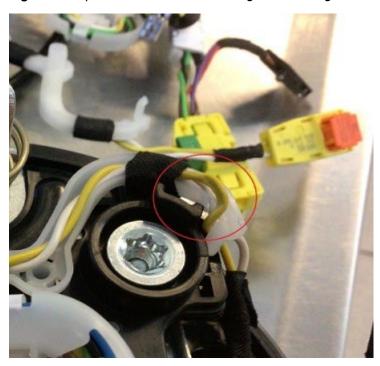
Incorrect routing of the driver airbag wire harness.

Figure 2. Damaged wire harness.

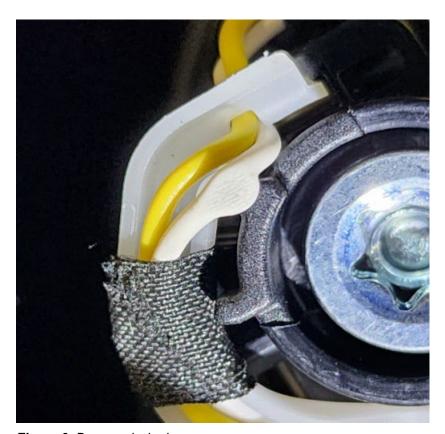
Figure 3. Damaged wire harness.

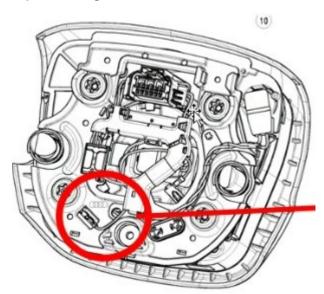
Figure 4. Inspect wire harness for damage and routing in the circled area.

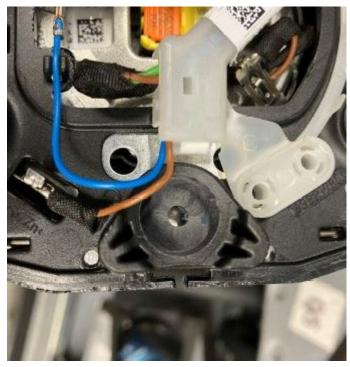
Figure 5. Check airbag wire harness for damage and routing.
