87 Air conditioning does not cool

87 23 63 2072166/1 November 30, 2023.

Model(s)	Year	VIN Range	Vehicle-Specific Equipment
A3, and S3	2022 – 2024	All	Not Applicable

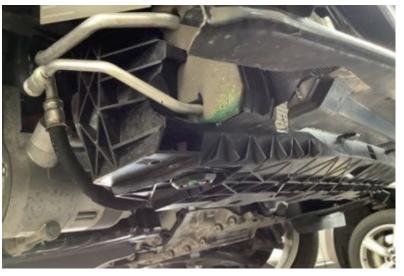
2. A refrigerant leak may be found at one or both refrigerant lines that connect to the air conditioning condenser, specifically the aluminum portion of the lines that are in contact with the seal strip as the lines pass through the lock carrier.

Figure 1. Location of the high and low side refrigerant lines.

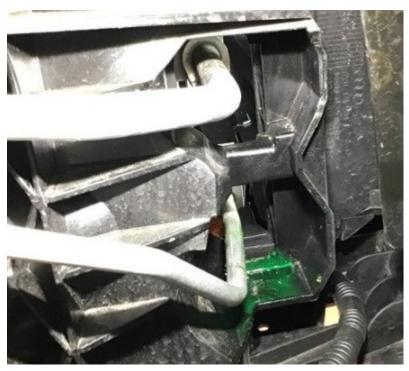
A refrigerant leak may develop due to corrosion formation in the aluminum sections of the high side and low side refrigerant lines leading to and from the air conditioning condenser, specifically the section surrounded by the foam sealing strip.

Figure 2. High and low side refrigerant lines routing through the lock carrier.

4. If a refrigerant leak is found at one or both refrigerant lines replace the line(s). Also replace the seal strip in these cases. When installing the seal strip ensure that the foam is installed in such a way that

it does not come in contact with the refrigerant lines. A small modification to the seal strip may be necessary.
