**RAPID UPDATE**

# Rapid Update 667 Grecale – Gearbox Wiring Check

DATE: OCTOBER 18 2023

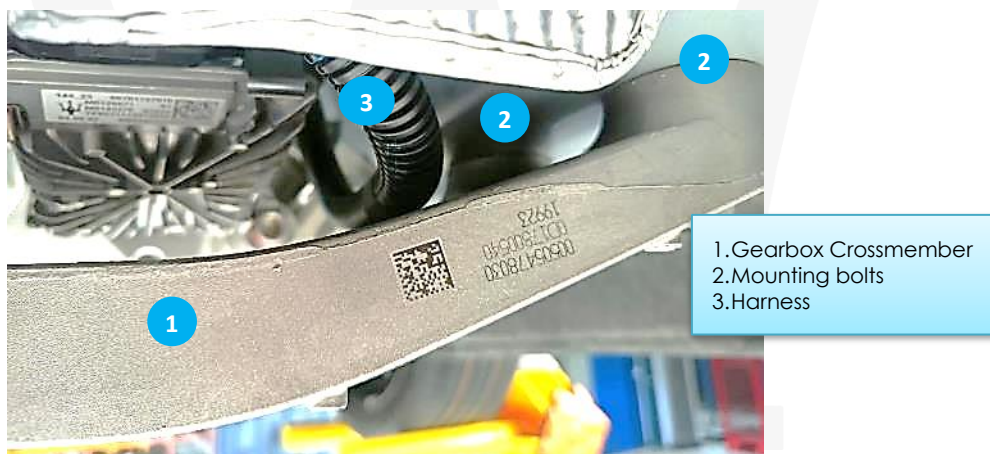
3. Check the gearbox wiring harness routing on the right side of the vehicle (as shown in the image below).

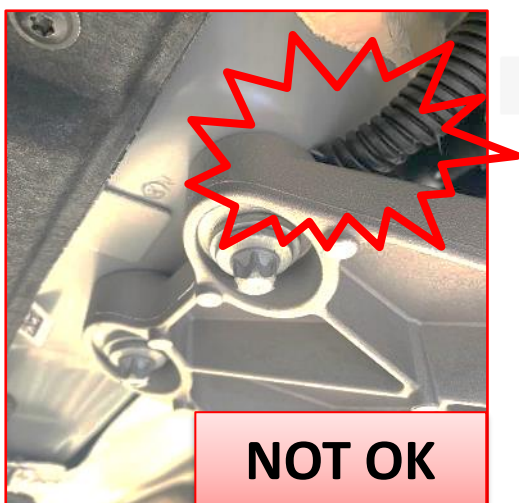
Harness is pinched between cross member and body

- **OK ►** No damage to the wiring harness is found. the procedure is finished. No further action needed.
- **NOT OK ►** Damage to the wiring harness is found. Proceed to replace the gearbox wiring harness (PN. 670216011) including the necessary hardware as indicated in the workshop manual sections ► **03.10.067 AUTOMATIC GEARBOX WIRING - Removal/refitting or Replacement and 03.10.063 00 GEARBOX MOUNTING CROSS MEMBER**

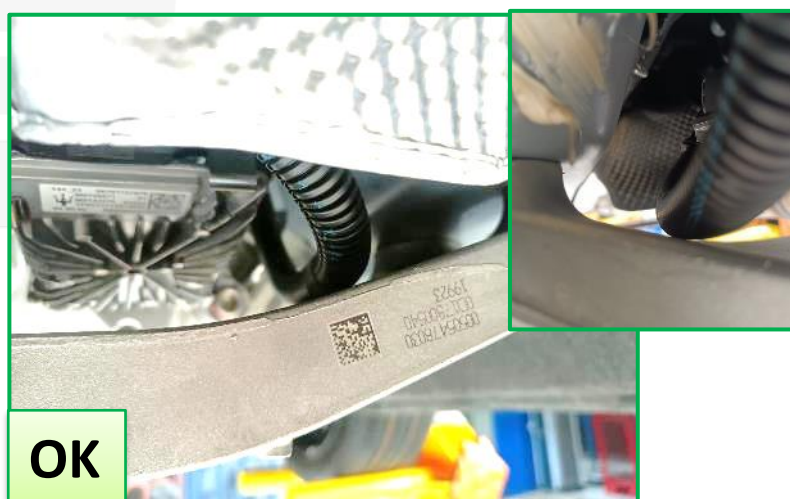
Harness is not pinched and is free and clear from cross member and body

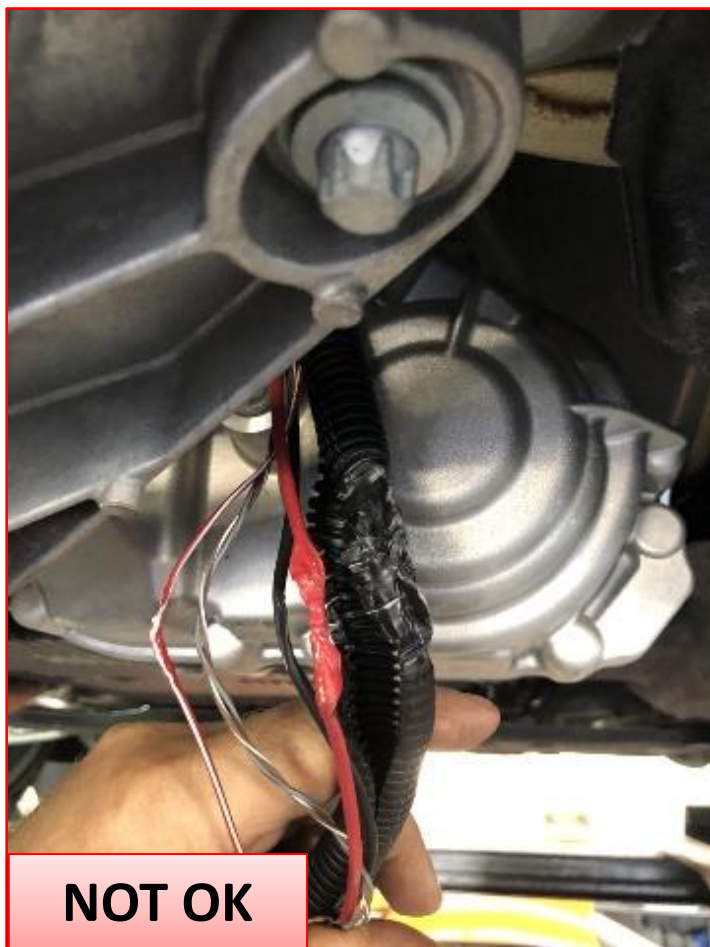
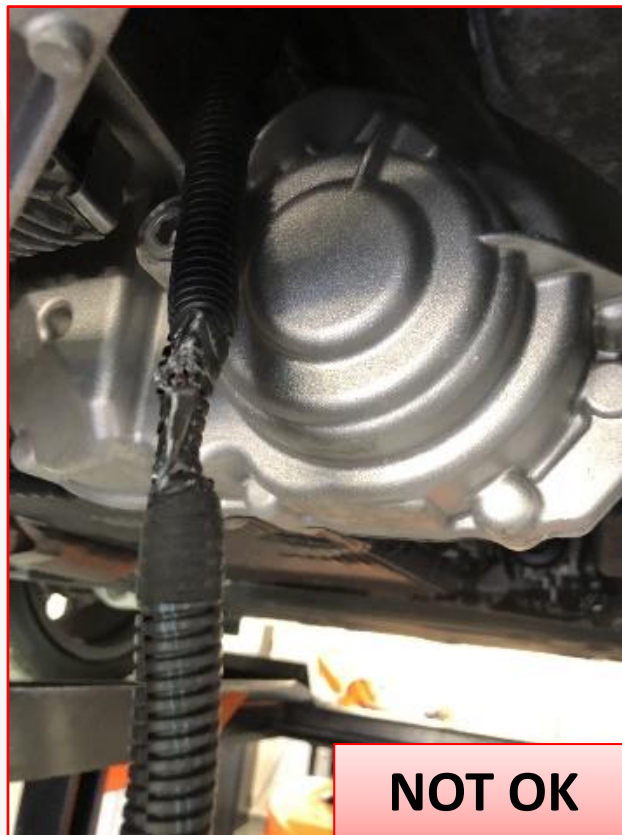
Examples of the Gearbox Harness damage as a result of being pinched between the Gearbox Crossmember and the body
