MAS003786 RU 23-53

# Rapid Update 669 Granturismo – Air Springs Check

DATE: OCTOBER 11 2023

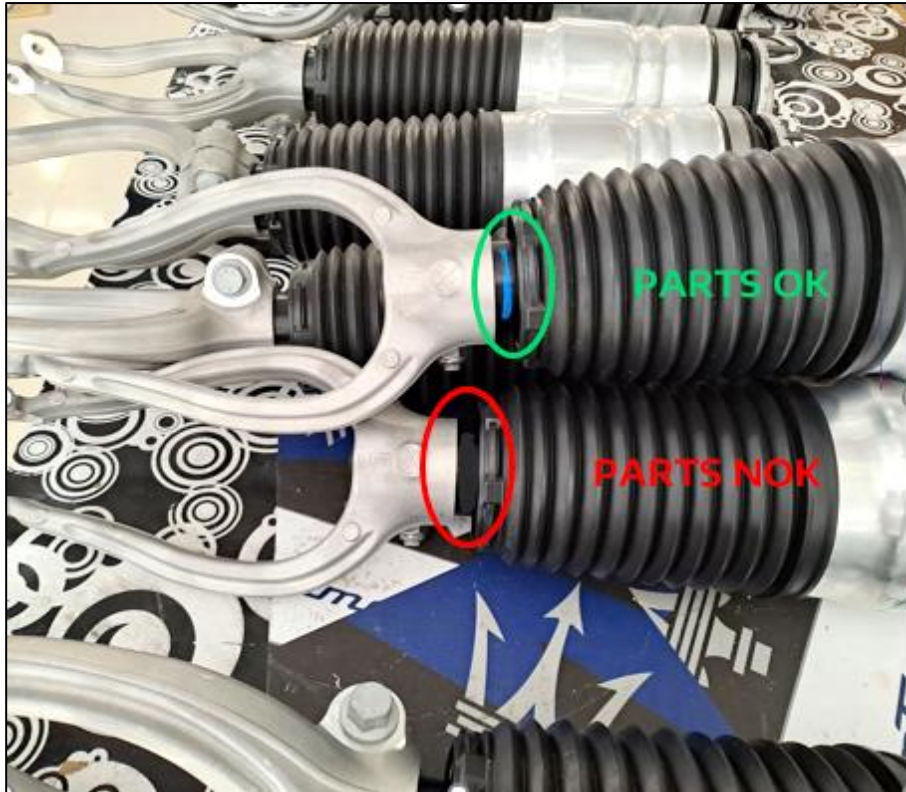
3. Place the car on the lift so you can carry out the check. The area to check is the collar on the edge of the suspension body. It is necessary to check whether there is a blue mark.

6. **Only replace the shock absorber that has the missing blue mark,** following the procedure in the workshop manual.

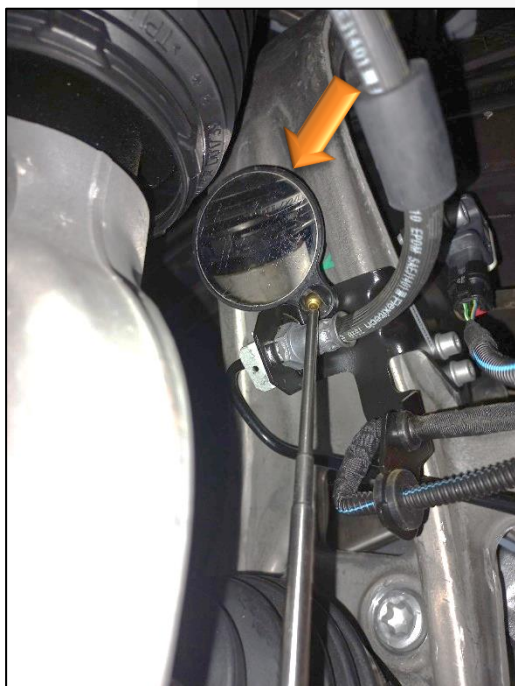
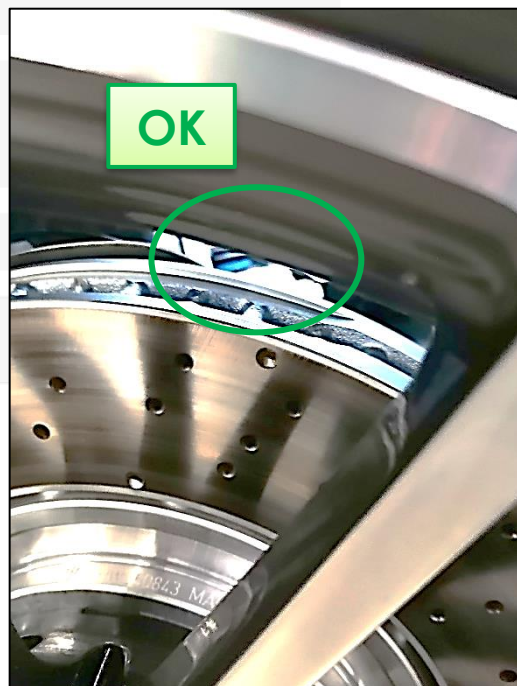
**Note:** Inspection of the blue mark on the shock absorber can be checked without removing the wheel Using a **telescopic mirror** and flashlight.
