# Rapid Update 671

## Grecale MHEV– 48V system – Four points Nut tightening torque check

DATE: OCTOBER 12 2023

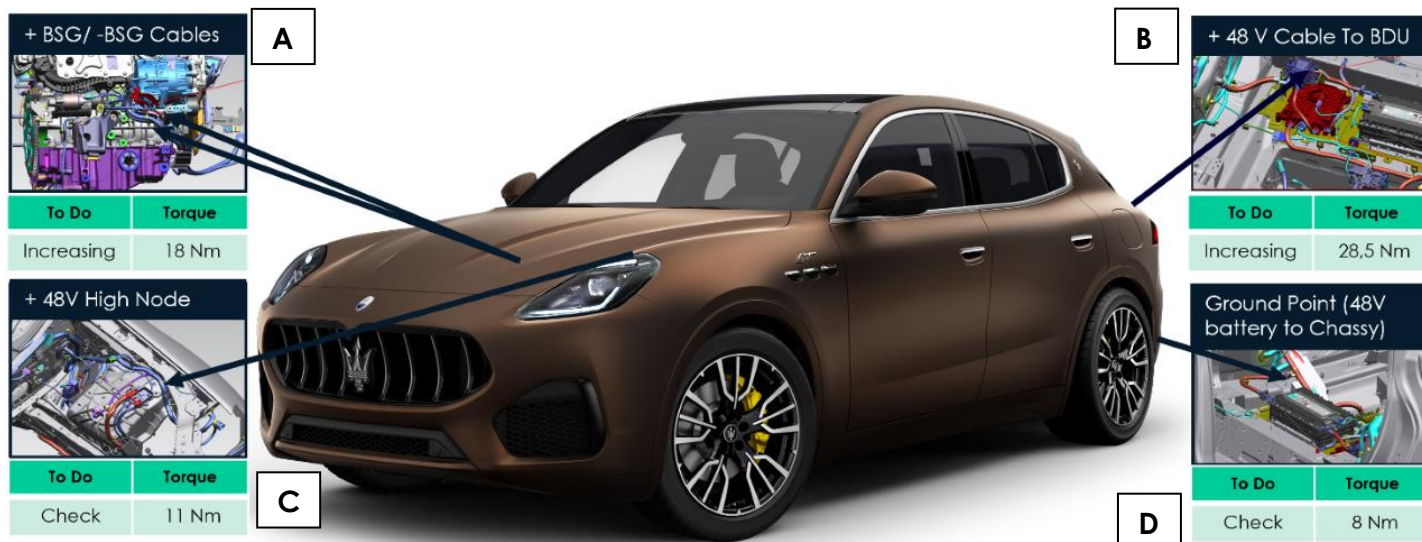
This campaign can be considered as an extension of Rapid Update #597 and #622, already communicated. It was found that a wrong tightening torque had been applied in production with potential electrical issues on the vehicle and Hybrid system malfunction or in some cases the complete discharge of the 12V battery. The remedy will require the inspection of four nuts located in the trunk and engine compartments, restoring the correct tightening torque.

To complete this rework, it is necessary to check the 5 points below:

- A. Positive and Negative BSG Cable on the engine block. -> Increased nut Torque to 18 Nm
- B. Positive 48V Cable to BDU in the trunk compartment -> Increased nut Torque to 28,5 Nm
- C. Positive 48V High Node in the Engine Compartment. -> Check Only (11 Nm)
- D. 48V battery to chassis Ground point in the trunk compartment. -> Check Only (8Nm)
