MAS003800 RU 23-57

Rapid Update 675 GranTurismo – Brake Pad Sensor Connector Check

DATE: OCTOBER 10 2023

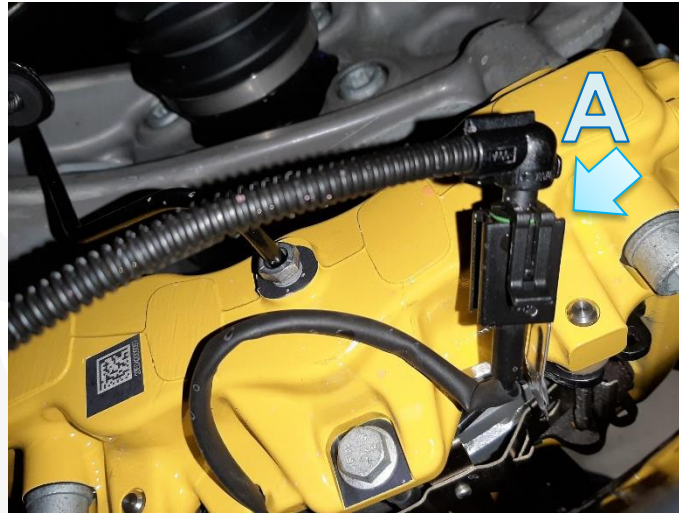
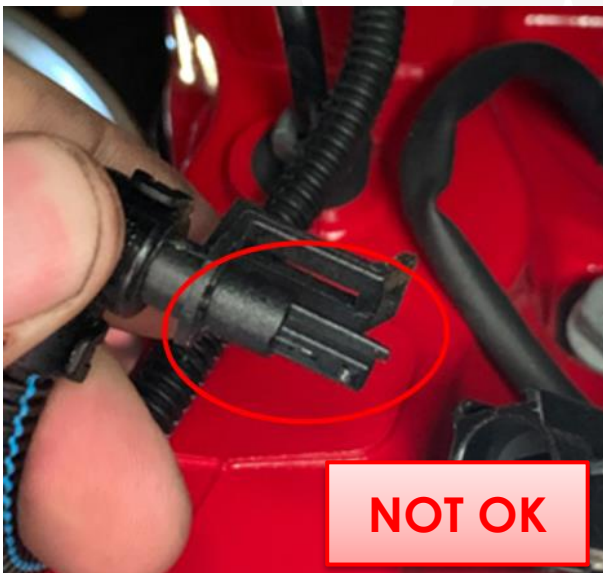
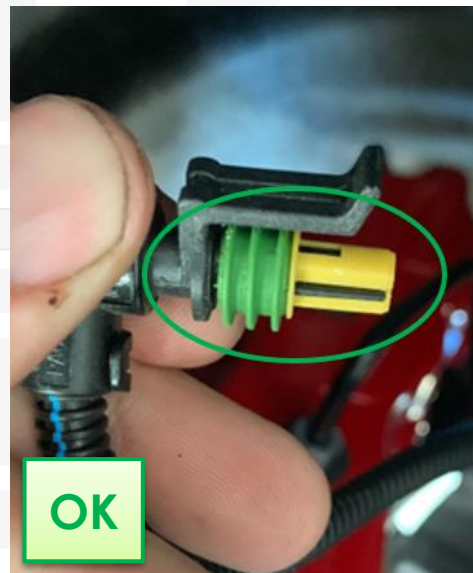
This action is necessary because, in a limited number of vehicles, the brake pad sensor connector weather seal and the protective cap may be absent. This issue has no impact on the functionality of the braking system. The procedure consists of inspecting the presence of these two components on the connector and possibly replacing them.

1. Always check ModisCS+ to see if the vehicle is involved in this action and if it has not been previously performed.
2. Disconnect the 12V battery following the procedure given in the workshop manual:
 - a. **08.20.001 - BATTERY - Connection-disconnection of electrical power supply**
3. Remove the front wheels following the procedure given in the workshop manual.
 - a. **06.00.002 LEFT FRONT WHEEL RIM. Detachment/reattachment**
4. Locate the pad wear sensor connector (A) on the caliper, and disconnect it to check the presence of the weather seal (in green) and the protection cap (in yellow).

5. Carry out the check on **both LF and RF brake pad wear sensors**.
6. **INSPECTION RESULTS:**
 - **OK** ▶ The Weather seal and the protection cap are present on both front pad wear sensor connectors. No further action needed.
 - **NOT OK** ▶ The Weather seal and or the protection cap are missing on either LF or RF pad wear sensor connectors. The affected connector will need to be replaced. Open BOL for "SUPPORT REQUEST" attach pictures and await further instructions.

1. Replace the connector following the procedure indicated in bulletin **MAS000766** and the workshop manual:
