# Rapid Update 648

## Maserati Ghibli, Quattroporte and Levante – High pressure fuel pump connector Check

DATE: OCTOBER 11 2023

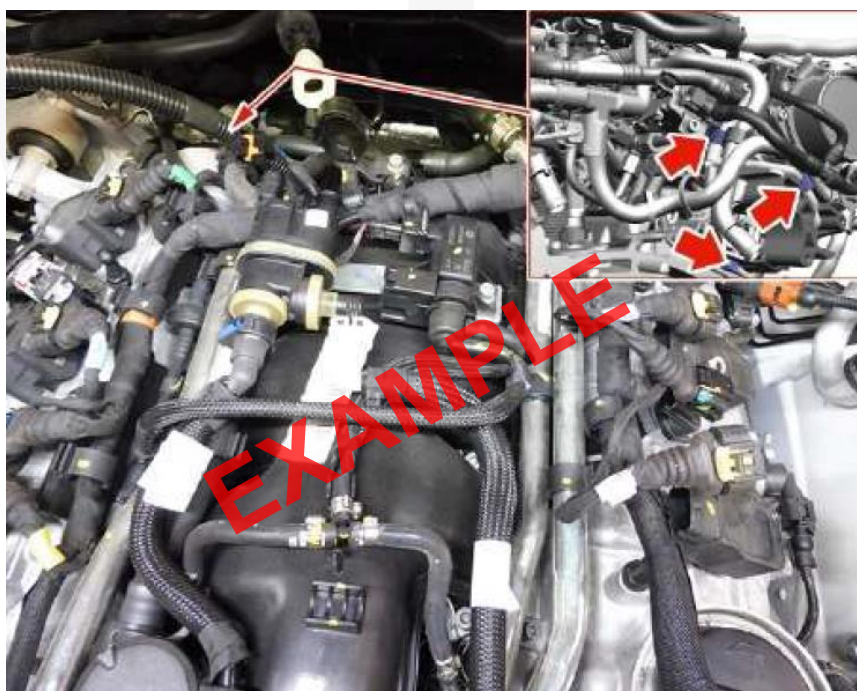
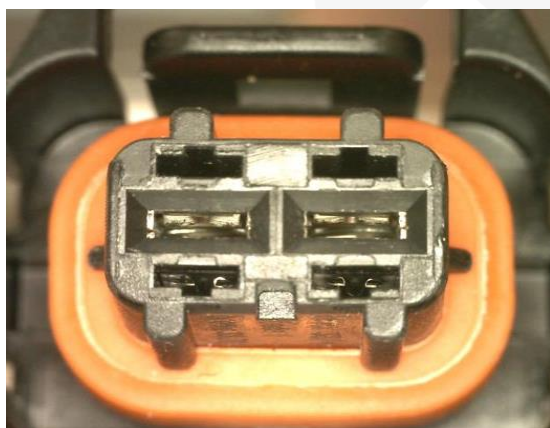
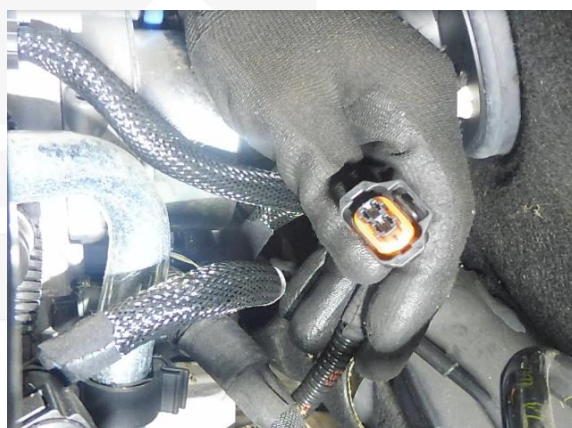
1. Always check ModisCS+ to see if the vehicle is involved in this action and if it has not been previously performed.
2. Disconnect the 12V battery by following the procedure in the workshop manual:  
**08.20.001 - BATTERY - Connection-disconnection of power supply.**
3. Locate the High-pressure pump connector. If needed, the workshop manual can be used as a reference for location ► **01.90.013 - CPL. ENGINE INJECTION CABLES - Removal-Refitting or Replacement. (Steps 21 through 24 depending on the vehicle.)**

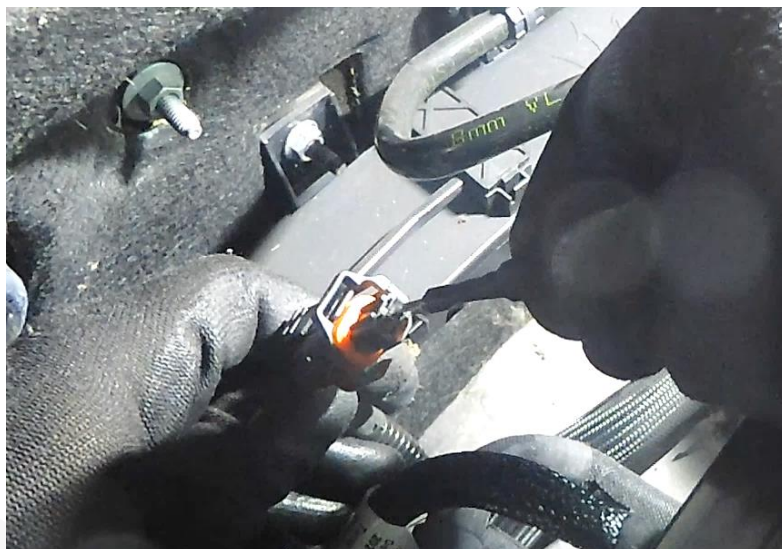
4. Insert the feeler (pin tension tool) in one of the two female pins of the connector.

5. With the tool inserted, perform a wiggle test on the connector (simulating vehicle vibration) to ensure there is no looseness in the female pin. Observe the tool and check if it comes out partially or entirely.

6. Perform the same procedure on the adjacent female pin inside the connector. (perform the test on **both** female pins)

- **OK ►** The pin tension tool remains well anchored inside both female pins. The pins are OK. No further steps are required at this point. Re-install all the removed parts following the procedure in reverse order and release the vehicle.
- **NOT OK ►** The pin tension tool comes out partially or entirely and is not well anchored inside one or both female pins. At this point, the connector needs to be replaced. Continue to **step 8**.

8. Replace the connector following the procedure indicated in the bulletin **MAS000766**. (For details, please refer to TechDOC procedure **0.30.005 - CONNECTORS REPAIR - REPLACEMENT – Warnings**). the kit to be used for replacing the wiring, refer to the equipment list described in bulletin **MAS000766**.
