Rapid Update 658/669

Maserati Granturismo – Replacement of air springs

Clarifications to the technical cycle

DATE: OCTOBER 11 2023

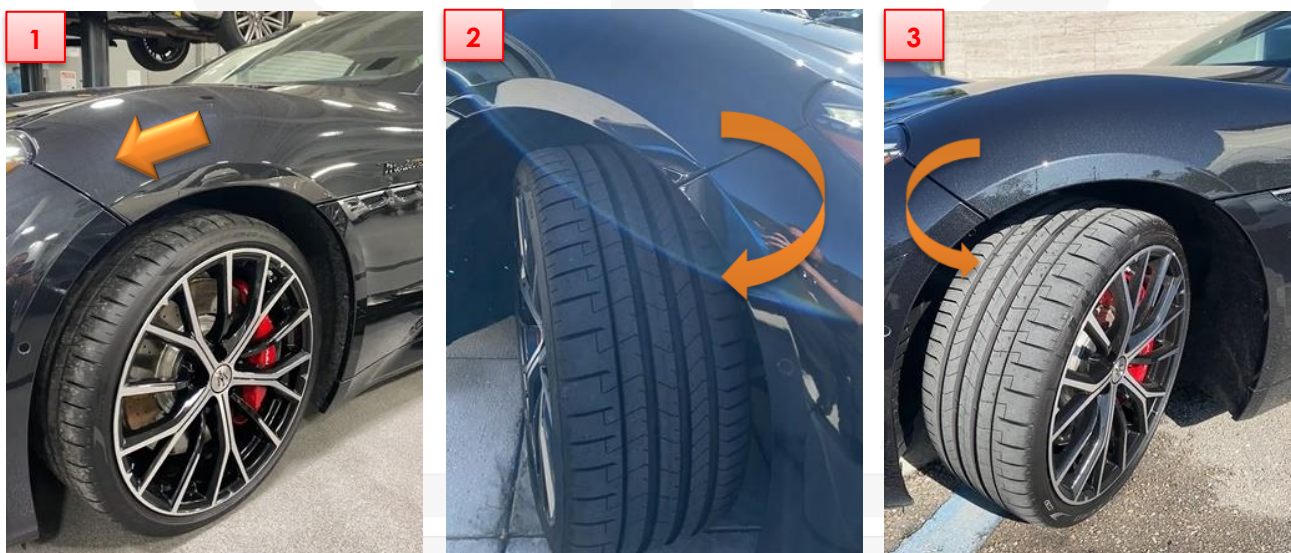
Start with the wheels pointing straight Turn the wheels fully locked to the Right Turn the wheels fully locked to the Left

2. Carry out a "Lock to Lock" maneuver. Starting with the steering wheel centered and wheels pointing straight ahead. Then turn the steering wheel completely to the right until reaching the end of its travel. Wait 30 seconds (while visually monitoring ride height) and repeat the operation by turning the steering wheel all the way to the left, always reaching the end of its travel.

3. Make sure the vehicle has not sagged, which is a sign that the shock absorbers have deflated.

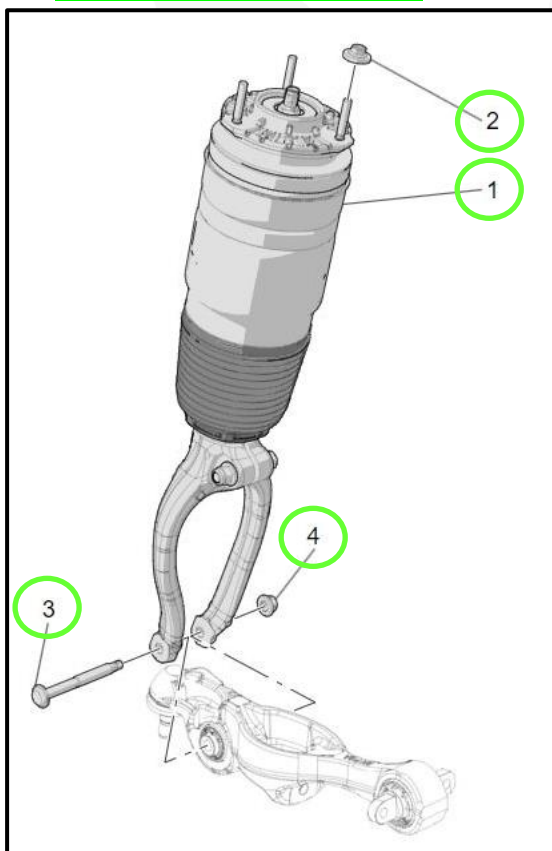
Components to be replaced

Following the replacement of the air springs as prescribed in **Rapid Update 658 & 669**, we observed a limited number of recurrences whereby after a test with a lock-to-lock maneuver, the car showed a lowering. In all registered cases, the PNs 670303906 and 670303902 with blue markings were used (which we will define as "old"). From the end of August, the parts 670309018 and 670309015 (which we will define as "new") are also available. Although the "new" and "old" parts are technically equivalent, no recurrences have been found on the new components. Therefore:

- We ask you to carry out the **Lock-to-Lock cycle** described in this bulletin every time the action (RU 658/669) is carried out to certify the outcome of the processing.
- We ask you to use only and exclusively components defined as "new" (PN 670309018 and 670309015).
- If you have any of the "old" (PN 670303906 and 670303902) in stock. We ask that you scrap them per the procedures mentioned in this bulletin. The cost of the component will be refunded by opening a Claim on Modis with the reason "Replacement Shock Absorber campaign". **See page 3 for details.**
- For cars already registered and delivered to the end customer, for which no anomaly has been found, no further action is required unless there is a specific complaint.
