**RAPID UPDATE**

# Rapid Update 673 Grecale – RFHM Software Update

DATE: OCTOBER 24 2023

Certain Maserati Grecale (M182) MY23 MY24 listed in MODISCS+ are involved in a Rapid to update the Radio Frequency HUB Module (RFHM) software.

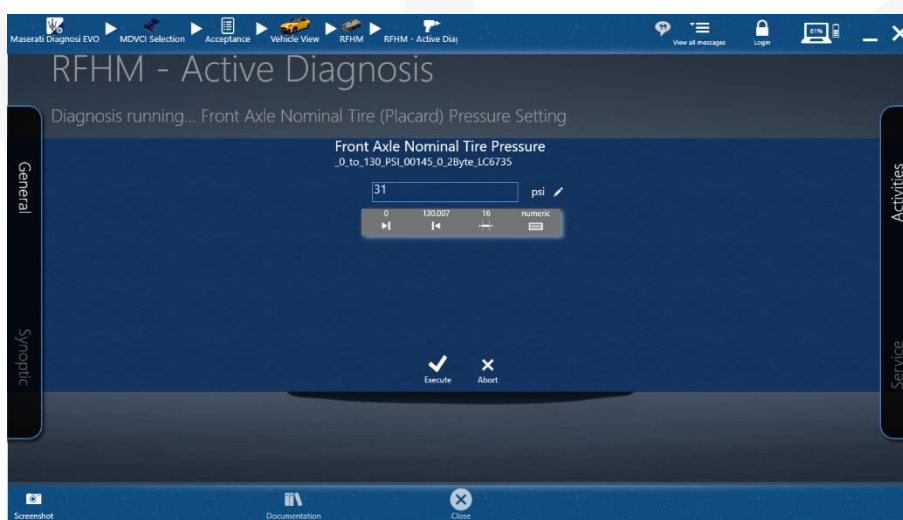
**\*\*IMPORTANT\*\*:** The modification from 30 to 31 in the active parameter is necessary to rectify an erroneous internal calculation in the hexadecimal conversion between psi and bar, and this adjustment is specific to 19" tires. It's essential to emphasize that there are no alterations to the tire pressure values as they are presented in the owner manuals and technical documentation. The parameter change solely aims to ensure an accurate internal calculation process.

3. Insert **31** in the text box and click on **Execute** to set the new value:
