**Volvo Car USA LLC****Quality Bulletin**

Bulletin Title Service Action A10246: Leaf Spring Inspect-Repair Model Year 2023 S60, V60, V60CC, V90CC, S90L, XC60, XC90		Group 72	NO A10246
Issuer (Dept.) Product, Safety and Compliance	Car Market United States and Canada	Issue Date 9/26/23	Status Date 10/16/23
Revisions 99922-2 & 98584-2 are to be claimed at the same time when replacing the leaf spring.		Page Page 1 of 3

A. SERVICE ACTION A10246 DESCRIPTION

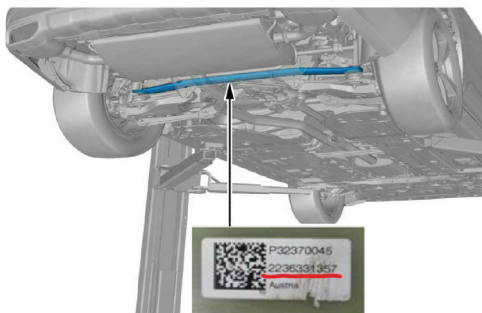
Volvo Cars quality investigations have identified that the wrong tool parameter setting was used during rear leaf spring production on vehicles built with rear leaf spring suspension. As a result, the rear suspension leaf spring may break.

In the unlikely event this should occur, Customers may complain of lowered vehicle ride height in the rear, harsh/bumpy ride, or noise from the rear of the vehicle while driving. Volvo has not received any reports alleging injuries, fatalities, or crashes related to this condition.

The corrective action is to inspect the leaf spring and only replace if the matching serial number is found in the Serial Number Matrix located in TIE.
