Bulletin No.: PIT6053A
Published date: 10/2/2023

PIT6053A Diagnostic Tip - Frontview Grille Camera Washer Nozzle Leaking

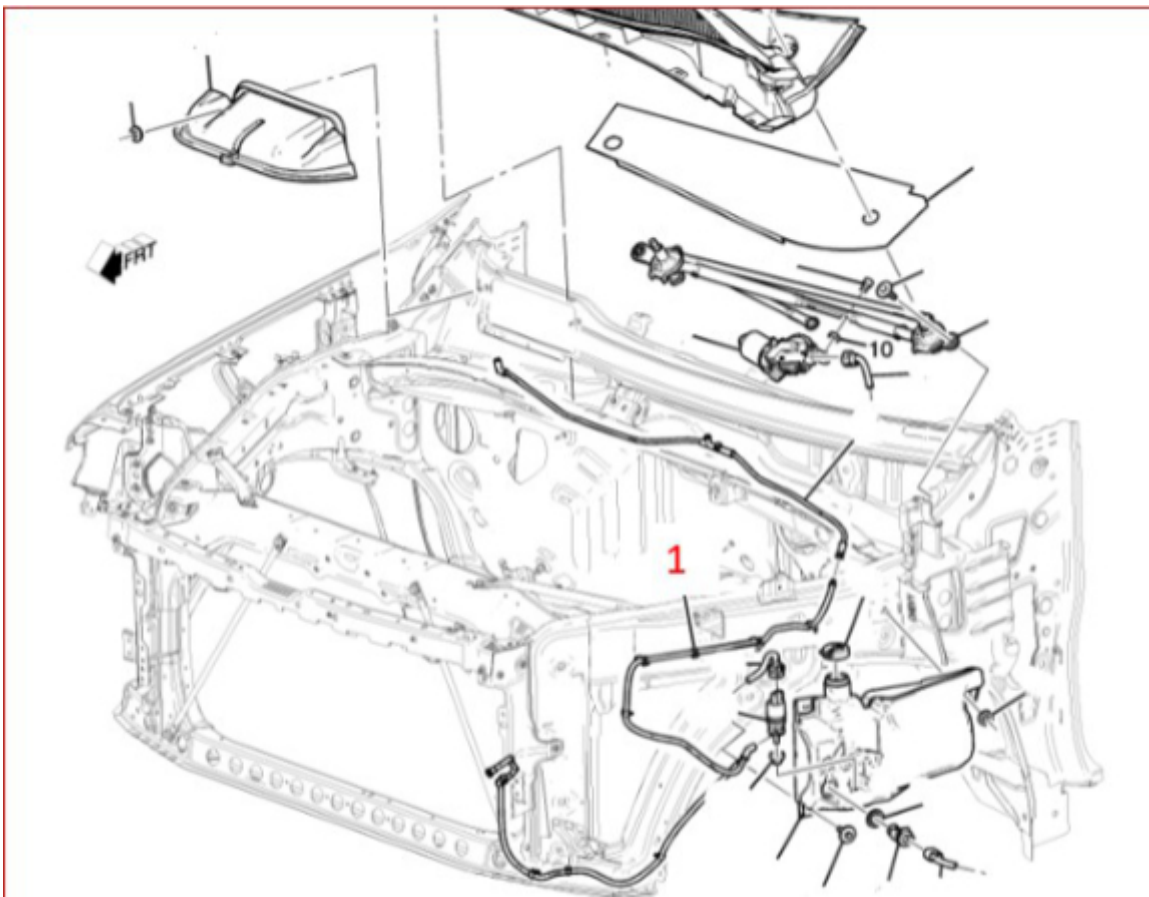
Involved Region or Country	North America
Additional Options (RPO)	UV2
Condition	Some customers may comment that the Frontview Camera Washer Nozzle is leaking washer fluid.
Cause	Service Information or the EPC/parts catalog does not show that there is a one way check valve built into the windshield washer hose that connects to the washer pump. This check valve is to prevent washer fluid from leaking.

If no other root cause is found, then the check valve is included with the windshield washer hose that connects to the washer pump (#1 below) and replace as necessary.
