Preliminary Information

PIT5966C OTA Failure or Download Will Not Complete / No Crank / Dead Battery

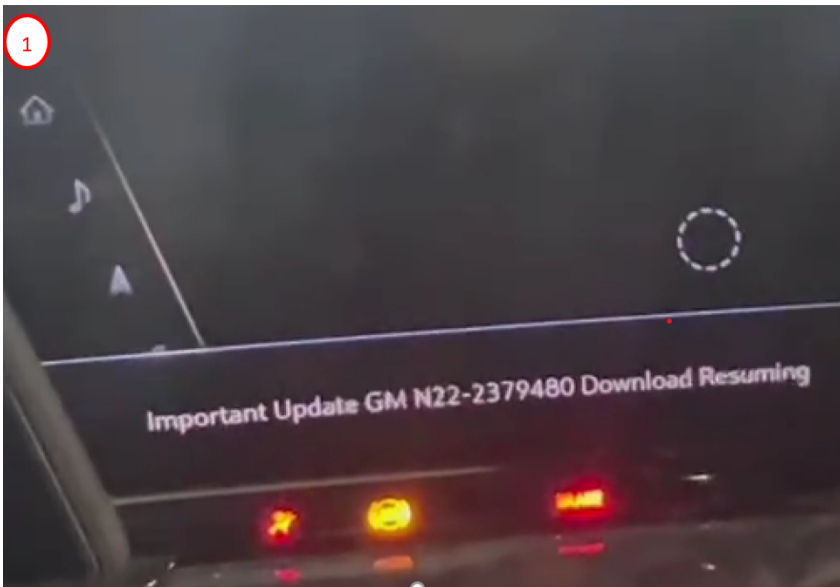
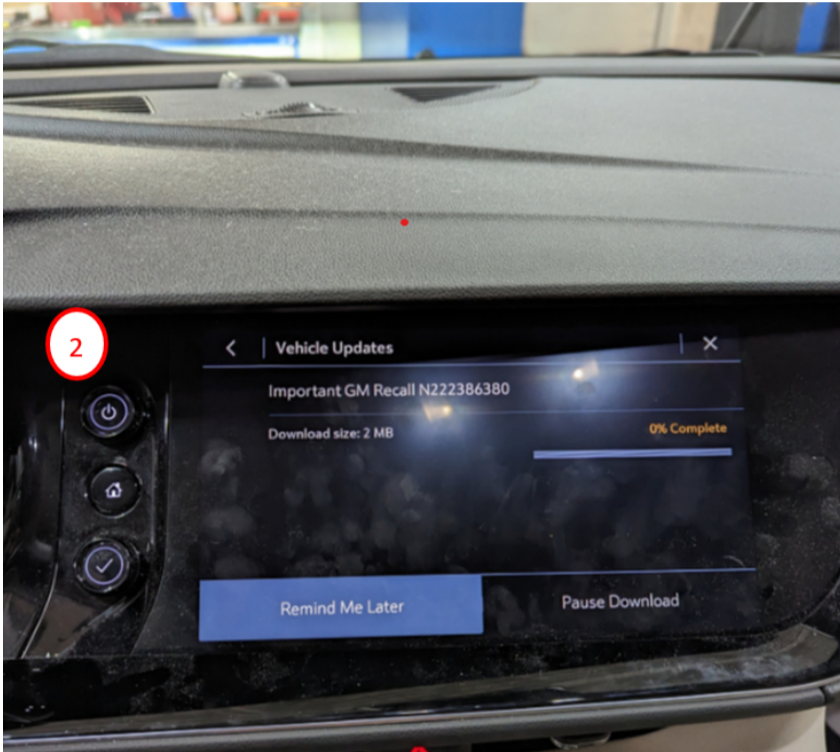
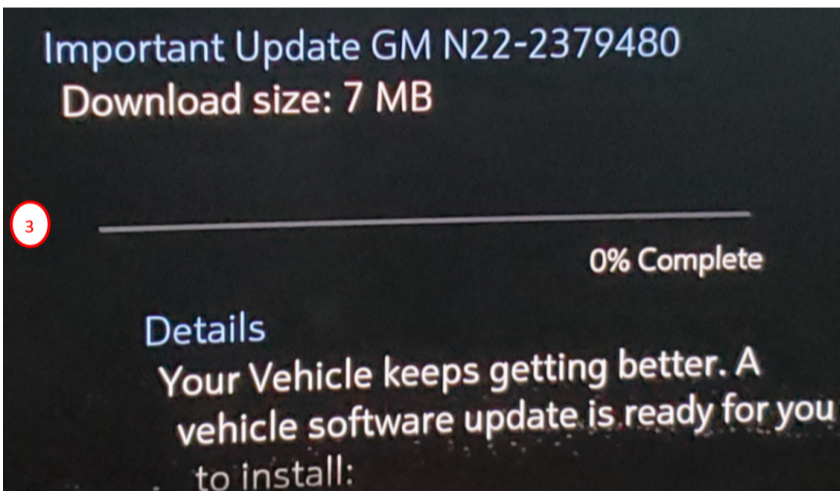
Involved Region or Country	North America
Condition	<p>Some customers may comment on any of the following complaints after an Over The Air (OTA) update:</p> <ul style="list-style-type: none"> - The radio will remain on for up to 11 minutes after RAP is canceled. - No Crank due to a dead battery. Vehicle will start and run after the battery is charged. - Intermittently at start up the radio display may momentarily display "Important Update Download Resuming". Example shown below (1). - When checking the Vehicle Update screen, it will show OTA failure, or an OTA available that will not complete. Examples shown below (2 and 3). <p>NOTE: These messages will indicate which OTA is being downloaded examples: N222379480, N22236683, N222386380, N22236410, N22236365, N222382220. Not all OTA campaign numbers will show up in Global Warranty under Required Field Actions.</p>
Cause	The cause of these concerns could be an OTA is stuck in a pending or download state.
