PIP5890A Information - DC Fast Charge Manual Lock Release

Brand:	Model:	Model Years:	VIN:		Engine:	Transmissions:
			from	to		
Cadillac	Lyriq	2023 - 2024	All	All	All	All

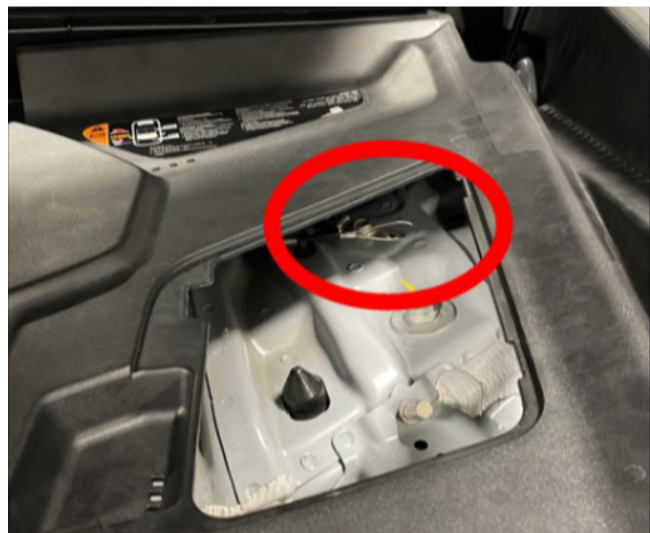
The cable is located under hood above the left shock tower and beneath a plastic trim panel, see Figure 1.

Figure 1. Cable location under hood with finger loop.

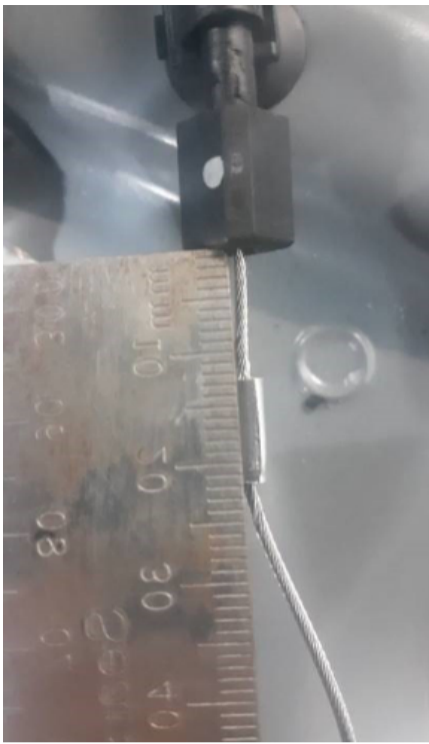
To determine if the cable has been fully retracted, make a measurement at the top end next to the loop as shown in Figure 2.

A cable with a longer measurement is not yet fully retracted.

Figure 2 – Proper length for a fully retracted cable (~12 mm).

Plug in for a DC Fast Charging event and allow the system to engage the lock to begin charging.

This lock engagement will pull the cable back into position.

Two or three short DC Fast Charging events may be needed to fully retract the cable.

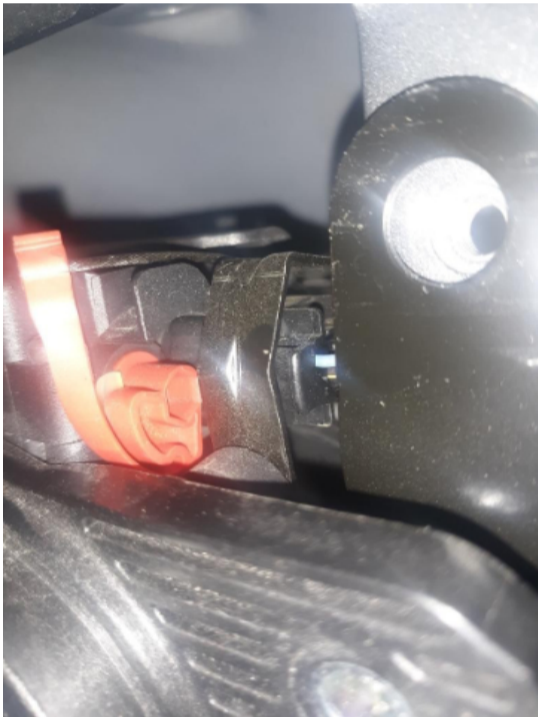
Note: Do not attempt to push the cable. The cable does not have a spring return, do not attempt to push on the cable after it has been pulled. Doing so will force the cable out of the correct position and cause problems with the mechanism as shown in Figure 3.

A cable with a shorter measurement may be in the improper position, such as from a pushing attempt to retract it (see Figure 3).

Figure 3 – View at the receptacle end with a cable in an improper position from being pushed.

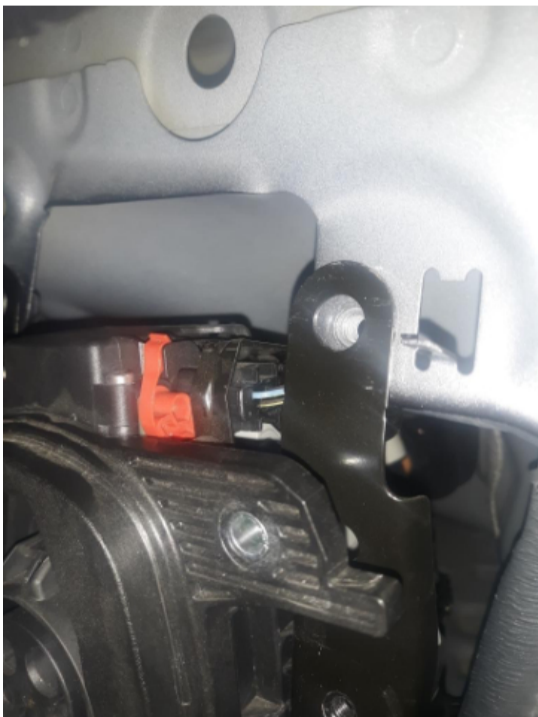
Figure 4 – View at the receptacle end with a cable in the proper position.
