PIT6072 Service Power Steering Message, No Crank / Start, Infotainment Issues, Door Locks Cycle, Multiple DTCs Possible

Brand:	Model:	Model Years:	VIN:		Engine:	Transmissions:
			from	to		
Chevrolet	Colorado	2023	All	All	All	All
GMC	Canyon	2023	All	All	All	All

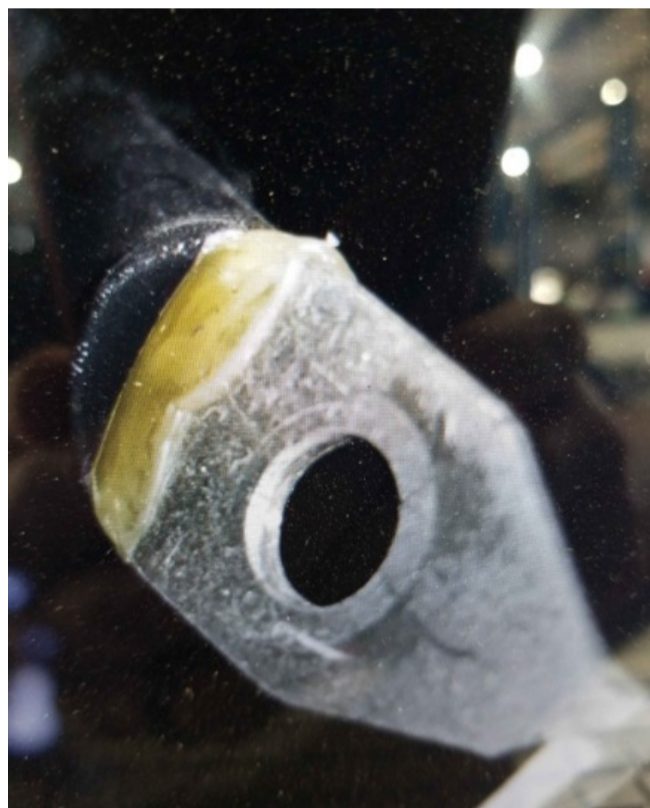
Involved Region or Country:	North America
Condition:	Service power steering message, infotainment issues, power loss, no start, no crank, door locks cycling, multiple communication or invalid data dtcs,
Cause:	Poor connection at G201B.

Inspect G201B. Verify that it is tight but you may find the heat shrink on the eyelet migrated and glue is interfering with the contact with the frame. Clean painted frame surface, remove excess heat shrink sleeve and glue from eyelet surface and re secure and retest. See example below.
