Bulletin No.: PIP5942
Published date: 10/20/2023

PIP5942 Diagnostic Aid for possible Low Clamp Load of the Negative Battery Cable the Block

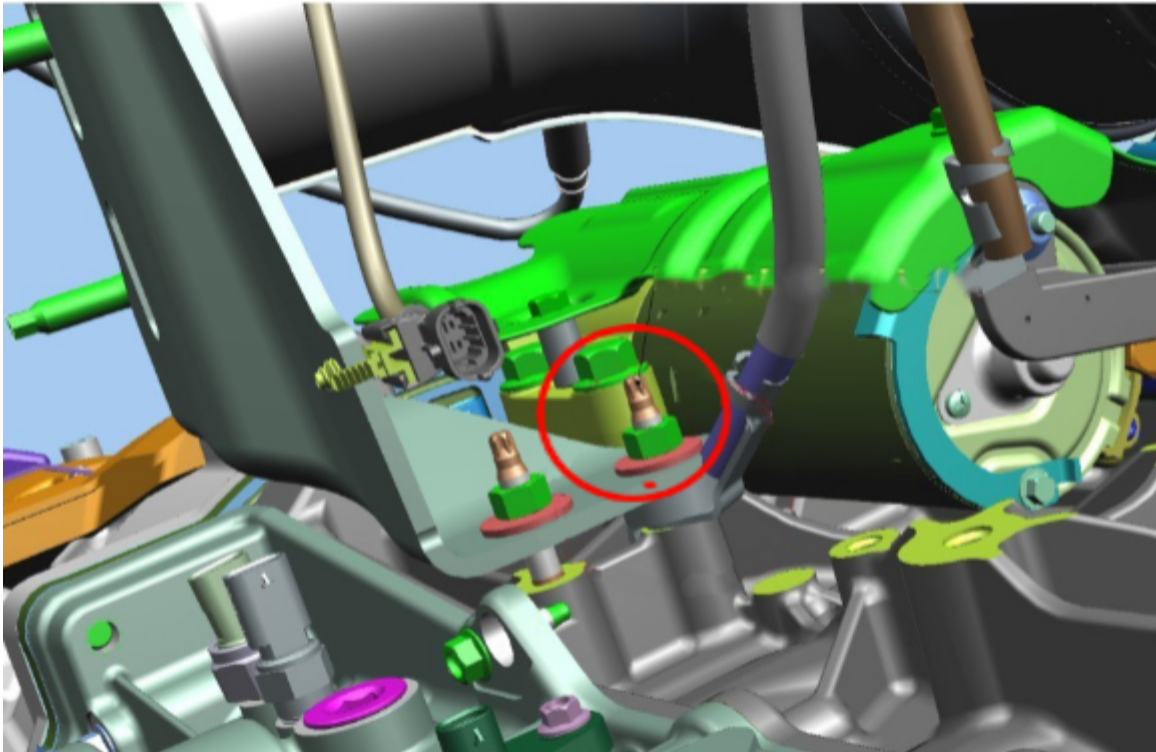
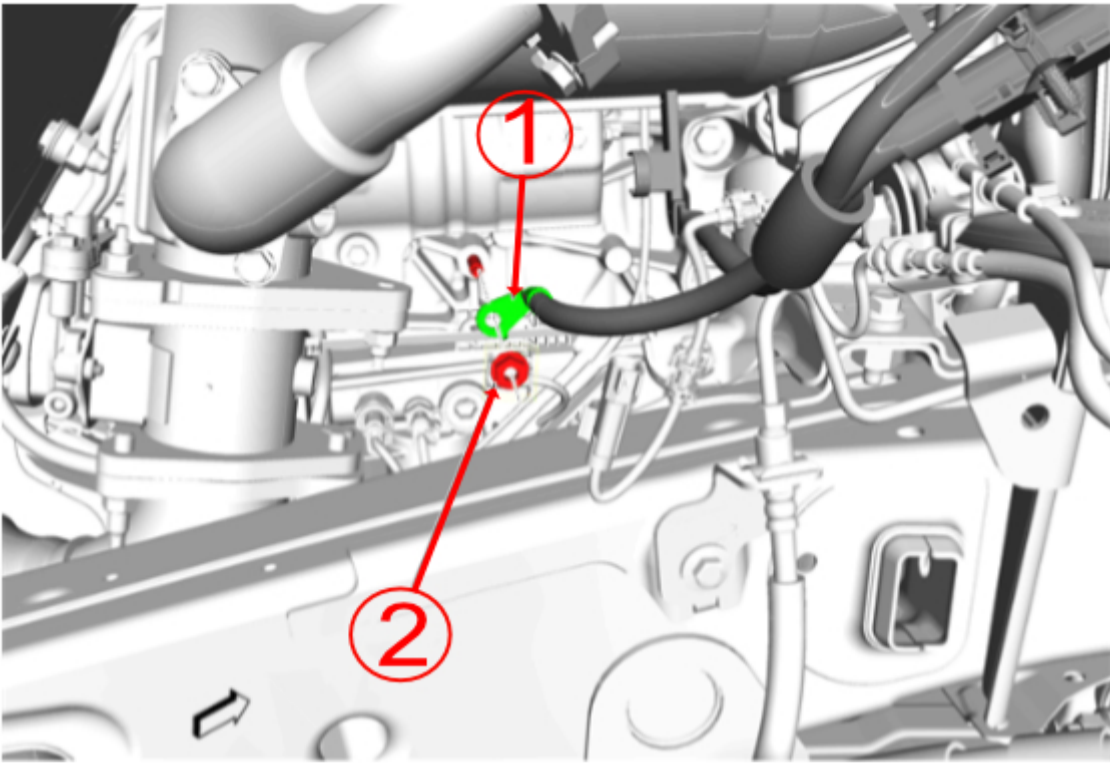
Involved Region or Country:	North America
Condition:	Multiple electrical issues, including but not limited to no crank, stall, erratic operation of the engine and lights.
Cause:	You may find low clamp load on the negative battery ground cable at the engine block (NOT the nut over the engine mount), due to the nut bottoming out on the shoulder of the stud.
