Seal, Weather Trim Strip (B-Pillar Trim) on Rear Doors Detaching

Topic number	LI72.12-P-076175
Version	2
Function group	72.12 - Rear door
Date	11/6/23
Validity	MODEL 206 206.0 FIN "F" up to manufacturing date: 18 January 2023 206.0 FIN "R" up to manufacturing date: 23 February 2023
Reason for change	Part numbers A 206 690 67 00 and A 206 690 68 00 replaced by A 206 690 75 04 und A 206 690 76 04

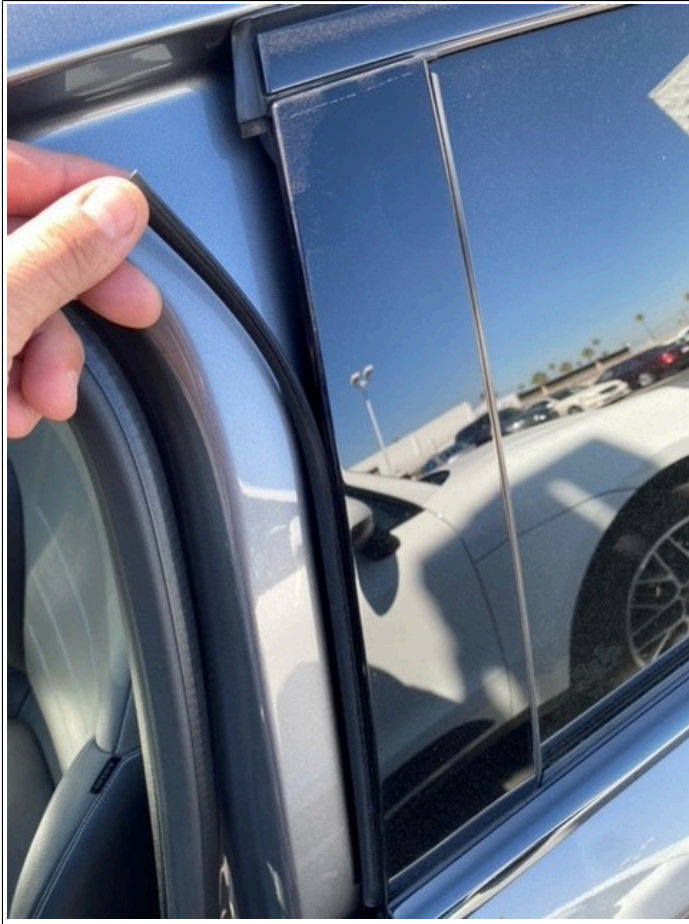
Attachments	
File	Description
Bild 1.jpg

Seal, B-pillar trim on rear doors cracked in upper area, see picture 1.

Production deviation at supplier of B-pillar trim.

Replace B-pillar trim through optimized parts.
